British Horology Times

Repairing a Daniel Quare Spring Clock

Lesson Learned – Beware of Assumptions

By Dennis Radage (British Columbia)

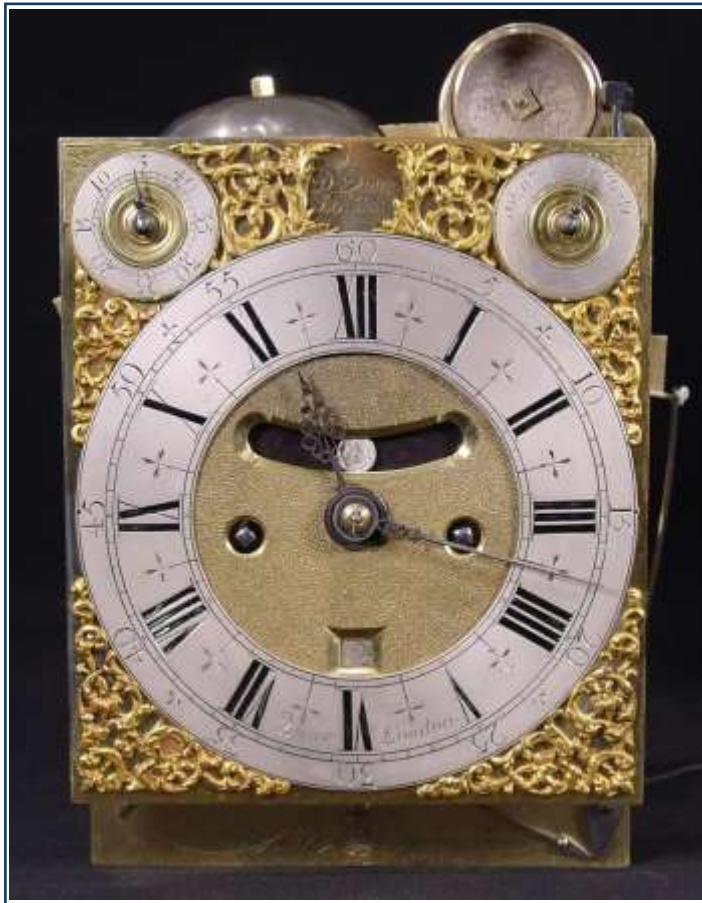
Figure 3: The movement removed from the case for examination

Figure 3 shows the movement out of the case. Note that the pull quarter cord had to be disconnected before the movement could be separated from the case. The hour bell and quarter bells can be seen to the top of the movement. Visual examination could not identify any issues, the clock continued to slow and stop. As with just about all spring clocks of this period, the going train had a verge and crown wheel escapement.

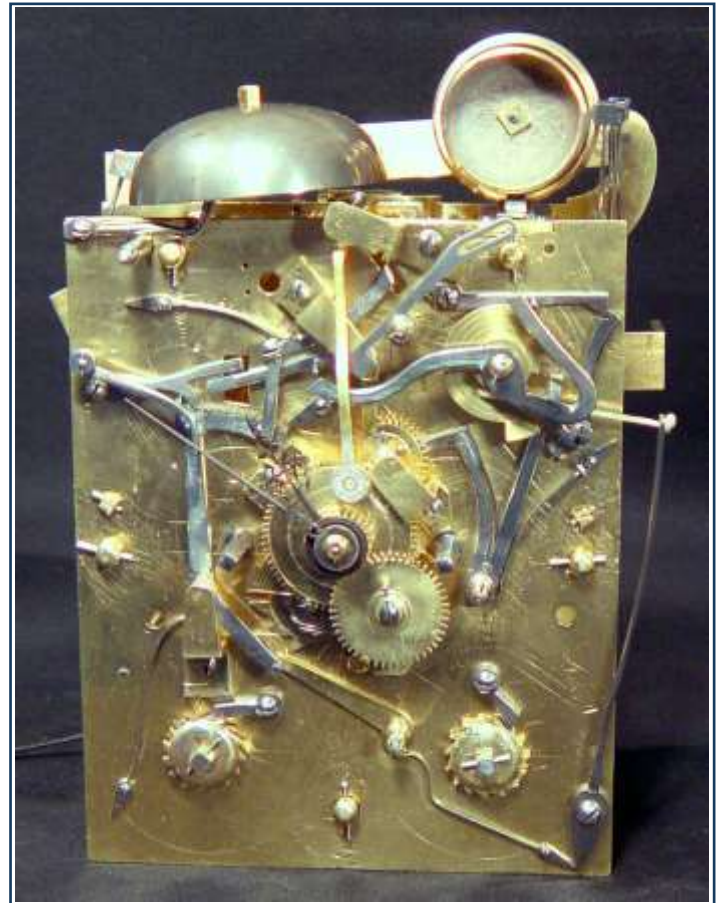
Figure 4: The complex mechanisms on the front plate of the movement

The hands were removed, then the dial was separated from the movement; this of course disconnected the subsidiary dials from their arbors and levers. Figure 4 shows the movement front plate. The motion work, false pendulum, rack striking mechanism and the quarter repeat mechanism are all mounted on the front plate along with the mainspring set-up clicks and ratchets. The minute hand was reinstalled so as to observe hour and quarter

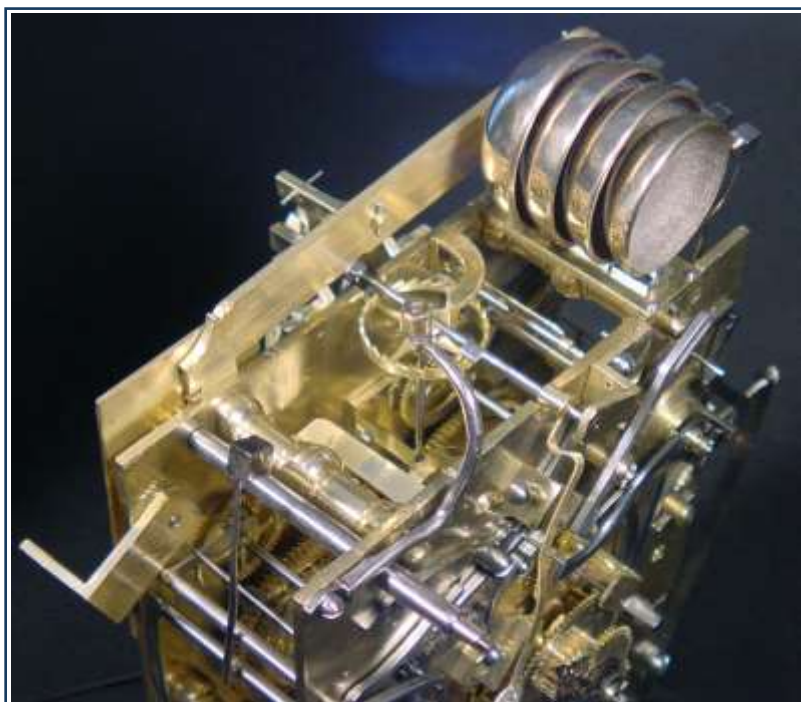
Figure 5: View showing the crownwheel with its top and bottom potencies

The crown wheel top potence (pivot) (as can be seen in Figure 5) was removed. This now allowed the removal of the crown wheel with its arbor and pinion that interface with the contrate wheel. The crown wheel was rotated that identified a slight unevenness. This was leveled. As no other issues were observed, the movement was reassembled, replacing all parts including the back cock and pendulum.

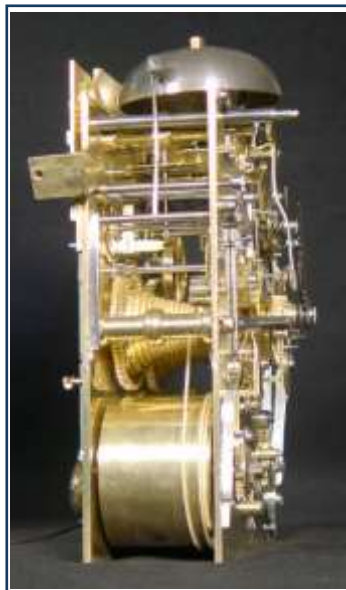
Figure 6: Bottom potence and contrate wheel

The mainspring was again let down, the pendulum and back cock removed, the pallet arbor was removed as was the top crown wheel potence, allowing the crown wheel to be lifted out yet again. The crown wheel arbor is pivoted in a lower potence which can be seen in Figures 5 and 6. It was noticed that the lower potence was blackened around the pivot hole. The lower potence was removed for examination. Both the upper and lower potence parts have two locating pins and each are held to the inside of the backplate by a single screw. Note

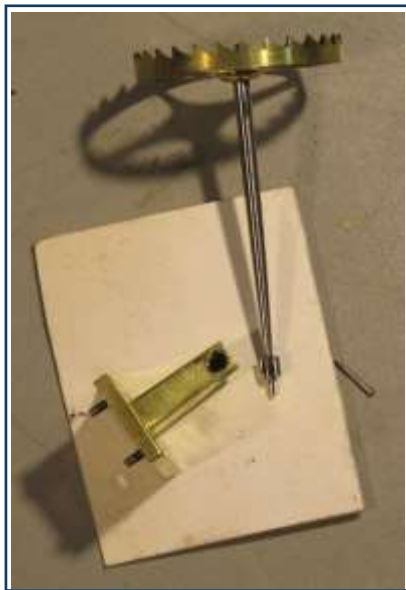
Figure 7: Bottom potence removed showing blackened crownwheel pivot

Examination of the lower potence exhibited blackened and gummed lubrication making this pivot area quite dirty, Figure 7. The lower pivot of the crown wheel arbor rests on a hardened screw which is mounted into the bottom of the potence, directly under the pivot hole. This acts in a similar manner to that of an endstone. The screw is used to raise and lower the crown wheel arbor, thus crown wheel, which allows adjustment of the drop of the verge pallets onto the crown wheel teeth.

The potence was cleaned, then examined. This looked to be in good condition with no serious wear. The crown wheel bottom pivot was also cleaned and then checked for fit in the lower potence pivot hole. A small amount of fresh lubrication was applied. The adjusting screw was turned one-half of one turn so as to improve the pallet drop. Since no additional issues were noticed, the assumption was that this assembly was now good.

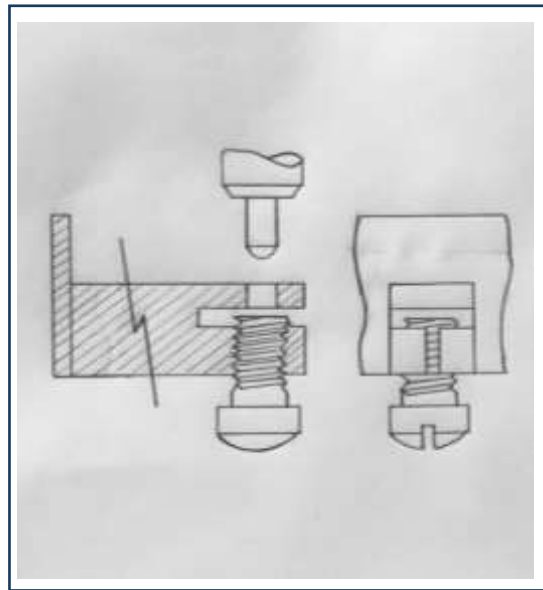
Figure 8: The bottom potence showing the correct shape of the pivot, and the positioning of the hardened steel adjusting screw

Instinct told me that the problem was indeed related to the crown wheel assembly, but there was nothing apparently wrong, at least, not obvious. It was time to take a break and read a little about early verge escapements, I read *Practical Clock Escapements* by Laurie Penman. I focused on the chapter describing verge pivots. One image in this book struck me as being quite different from what I could recall, related to the shape of the lower crown wheel arbor pivot. Figure 8 is an image similar to page 29, Figure 2.29 of the Penman book. This suggests that the correct shape of the pivot should have a rounded end, thus having just a single contact point.

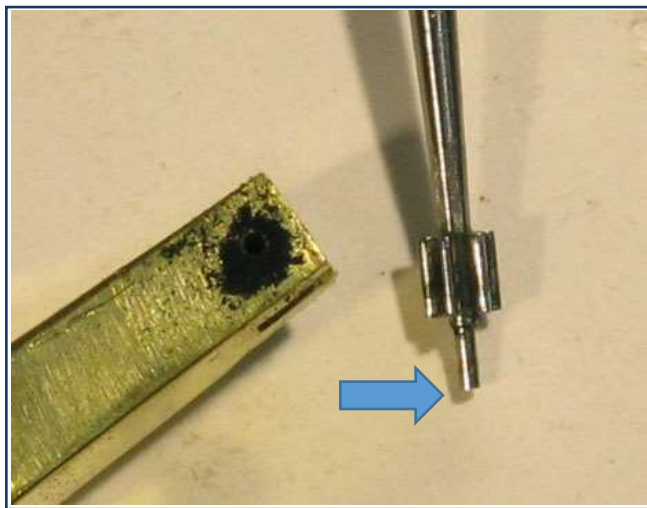
The mainspring was again let down and the pendulum, back cock, verge arbor and top potence were removed again. The crown wheel was removed. What became very clear this time is shown in Figure 9. The bottom pivot end was flat with a sharp edge. This pivot rotates on the hardened steel adjusting screw. A flat pivot end would introduce considerable friction when rotating on this screw.

Figure 9: Bottom crownwheel arbor pivot has a flat bottom with sharp edge. This was causing considerable friction, wear and blackening of the pivot

Using stones, this pivot was properly rounded, then polished. After cleaning, the clock was again reassembled and power was applied to the mainspring. This time, when set in motion, there was a marked improvement. The pendulum swung with vigor, there was no stopping it this time. Problem identified and corrected.
