British Horology Times

A Brief History of the Great Clock at Westminster Palace Its Concept, Construction, the Great Accident and Recent Refurbishment

By Mark R. Frank ©2008

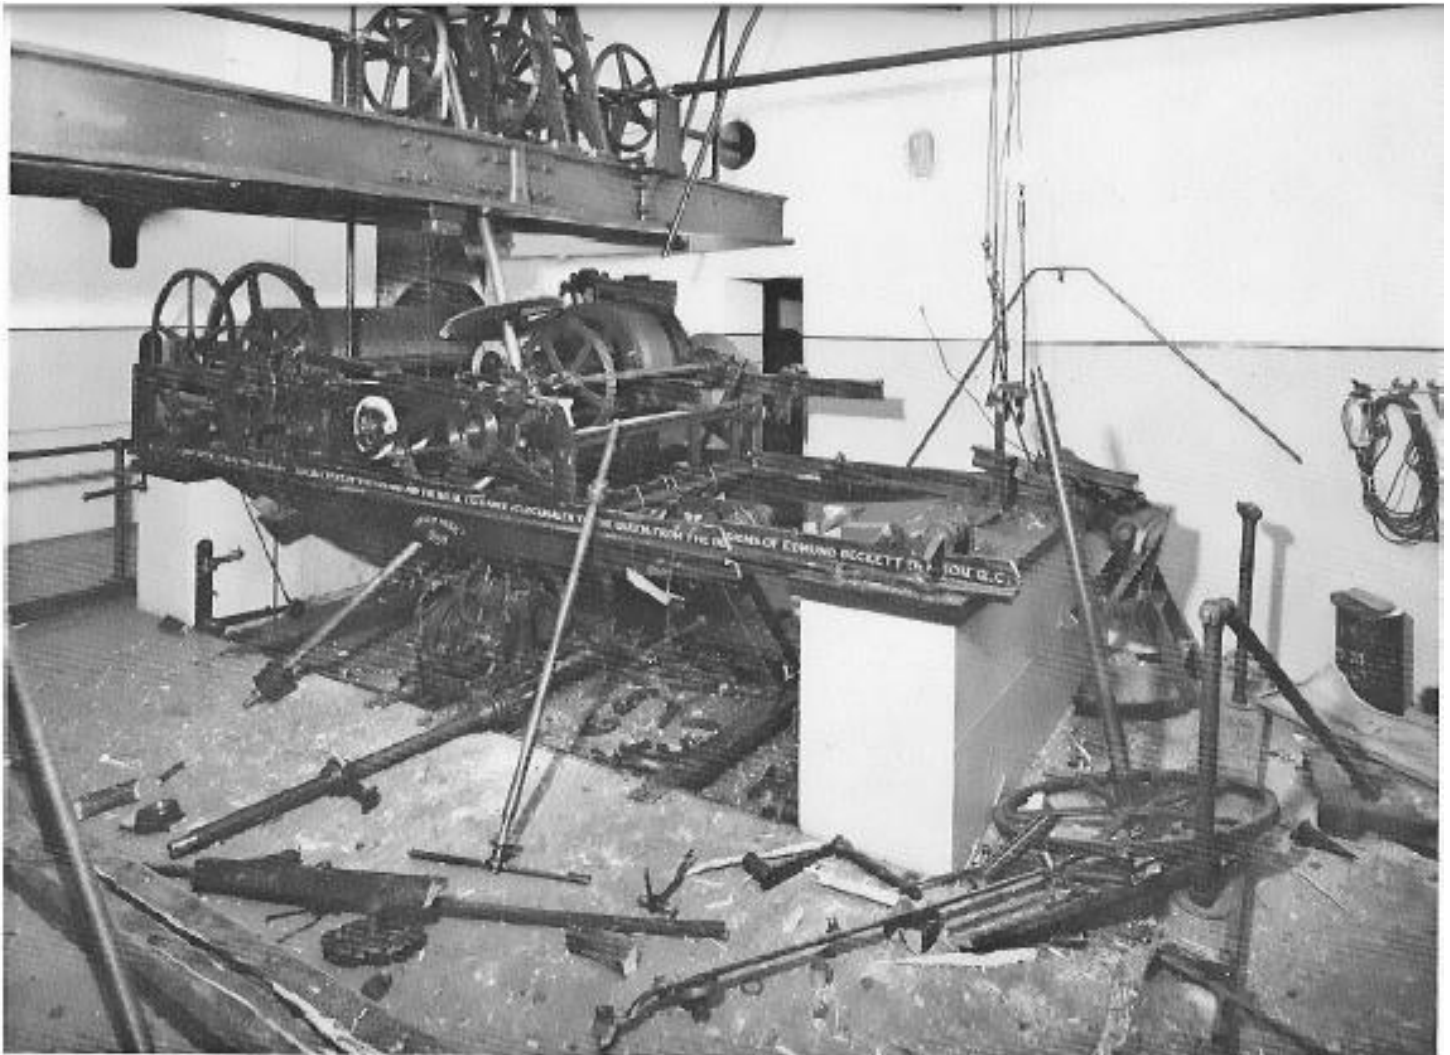
Photo 1. Chime train and frame stripped away. Count wheel attached to its frame and laying in the foreground.

Notice in the first post event photo, above, the section of the top frame rail with the quarter count wheel (known as a locking plate in England) still attached laying in the foreground. The lower main frame front member with the dedication inscription is broken about one-third of the way from the right end of the damaged chime area. The main frame was broken in five places. At the top, middle portion of the photo one can just see the fly fan drive tube hanging next to the motion works lead off support girder. In the photo next page, this is more apparent as the fly itself is partially supported by the remaining fly steady which is attached to the upper girder with the balance of the fly entangled on the lead off wheel nest. The next page shows two other angles of the movement as well as views of where the chime barrel came to rest.

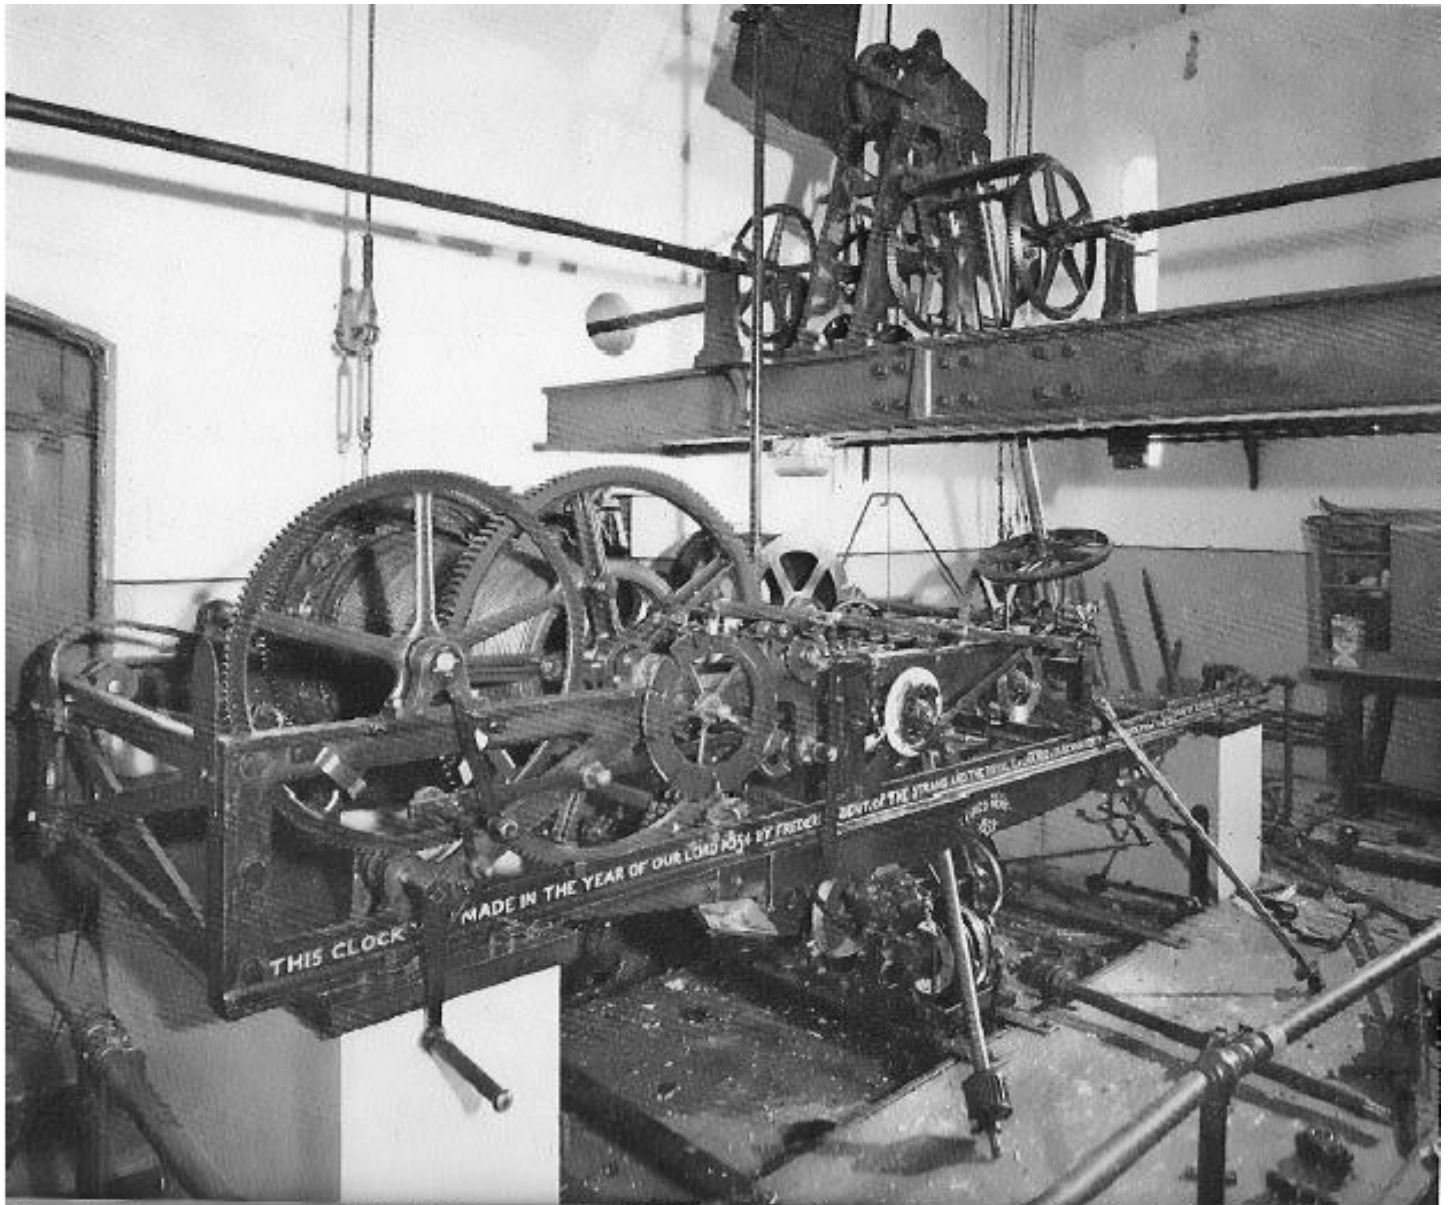
Photo 2. Three-quarter view left side. Damaged fly is left hanging on its steady; entangled on the lead-off wheel nest.

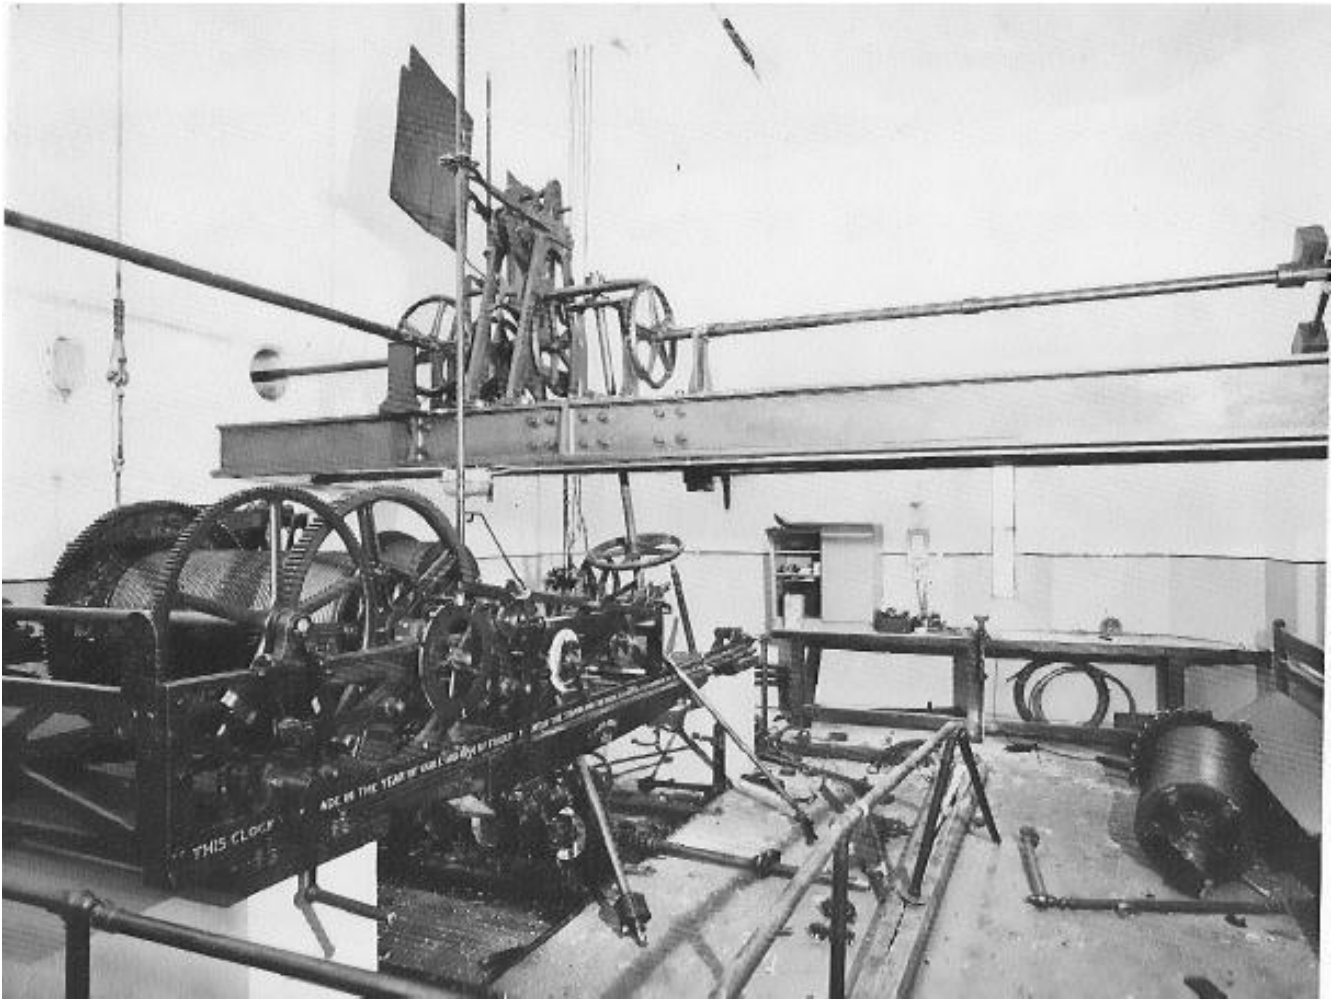
Photo 3. Strike side view and showing where $\frac{1}{4}$ ton chime barrel came to rest.

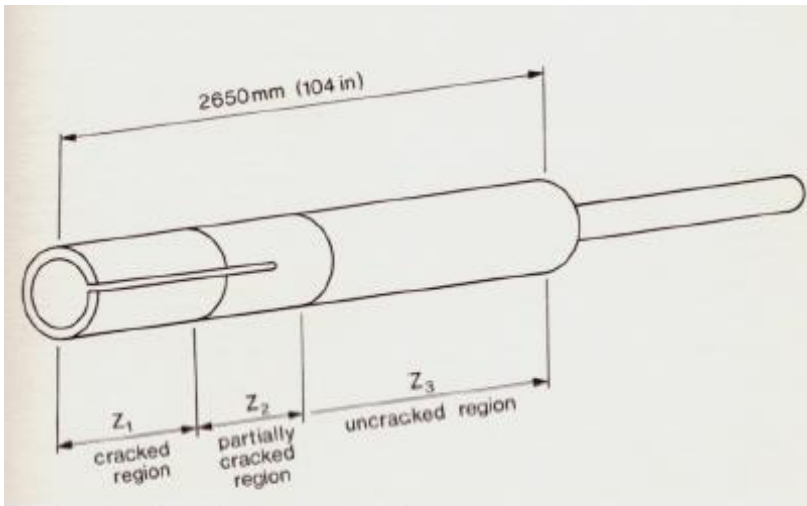
A crack had initiated, probably in the lower end of the tube, which developed into a fatigue crack. This propagated for 1 m (40 in) along the tube, at which stage transverse cracks developed; these extended halfway around the circumference of the tube before secondary helical and longitudinal fractures developed during the final stages of the tube failure.

Fig. 1. Tube schematic showing main fracture.

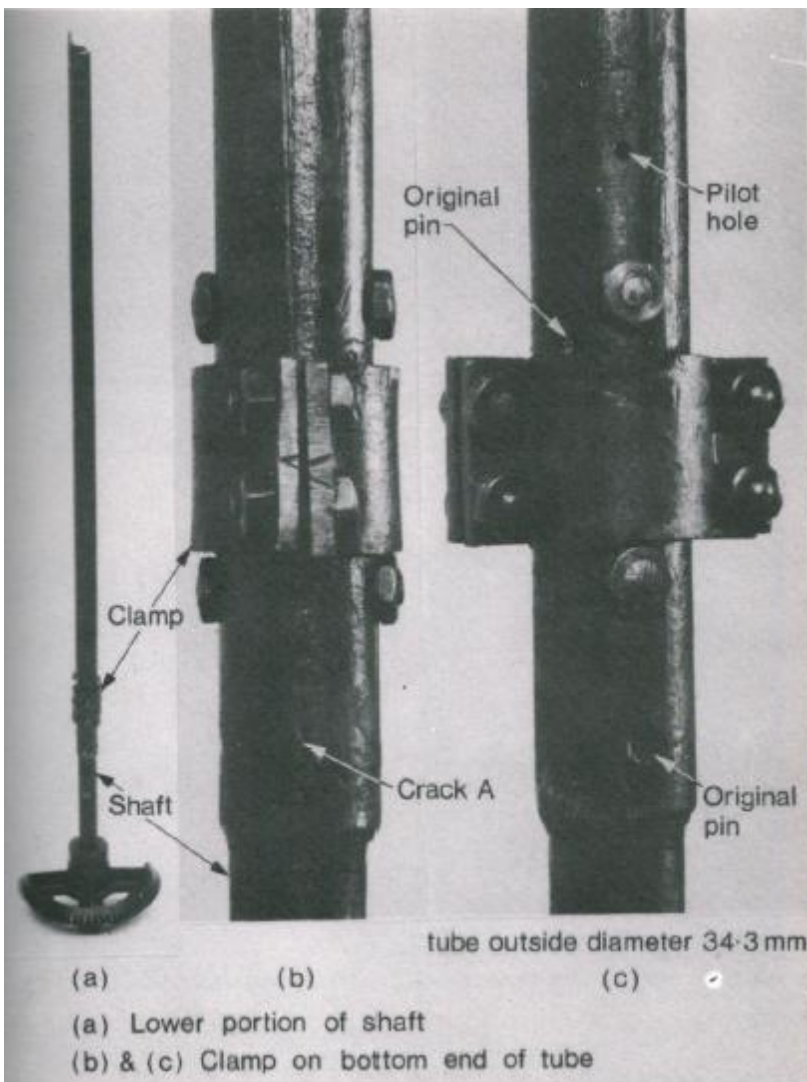
Lower half of the broken tube and its bevel, (Fig 2).

The pipe clamp was installed in the 1956 overhaul to keep the bevel wheel arbor from slipping within the tube. The fly governor is a critical part of the chiming mechanism since the fly acts an air brake to control the rate of chiming, and hence the speed of the mechanism. There was extensive fatigue cracking in the wrought iron tube component of the vertical shaft. The main fatigue crack (a), which followed weld seam along the length of the tube, extended approximately 40 inches from the lower end of the tube where it was attached to its driving bevel gear wheel. Because it was masked by the welded seam, and because the outside of the tube was a dark grey color covered in parts with a black oxide scale, the crack was not easily discernable, apart from the first few inches at the lower end, marked 'Crack A'.

Fig. 2. Chime drive shaft with damaged bevel drive wheel.

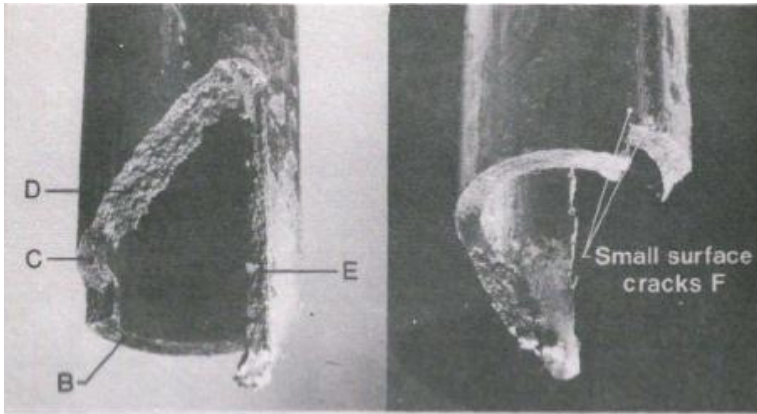
Fig. 3a. Upper chime tube fracture area.

Broken ends of the chime tube, upper portion, (Fig 3a) and lower, (Fig 3b).

Circumferential fatigue cracks had developed near the leading end of the longitudinal crack marked A, and the two which lead to the failure of the fly shaft are marked B and C. These cracks which were initially approximately perpendicular to the axis of the tube, changed to a helical mode with that at D running 45o to the tube axis. The region of final failure was manifest

A macrograph of the weld region in the upper portion of the tube 100mm (4 inches) above the circumferential crack marked C (*Fig 3a*) is shown below, from which the fibrous and laminar nature of the material is apparent. The flow lines indicate that a form of butt weld was made, and a bulge marking the junction where the two ends of the joint were forced together is evident, especially on the inside of the tube. The area shows the presence of a stress raising notch at the inner surface of the tube.

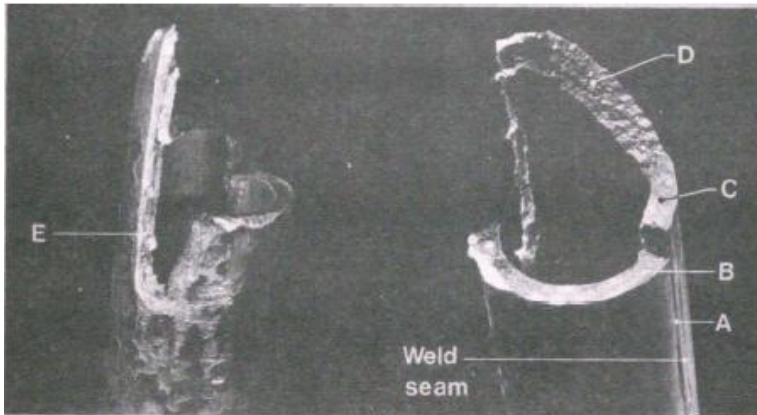
Fig. 3b. Lower chime tube fracture area.

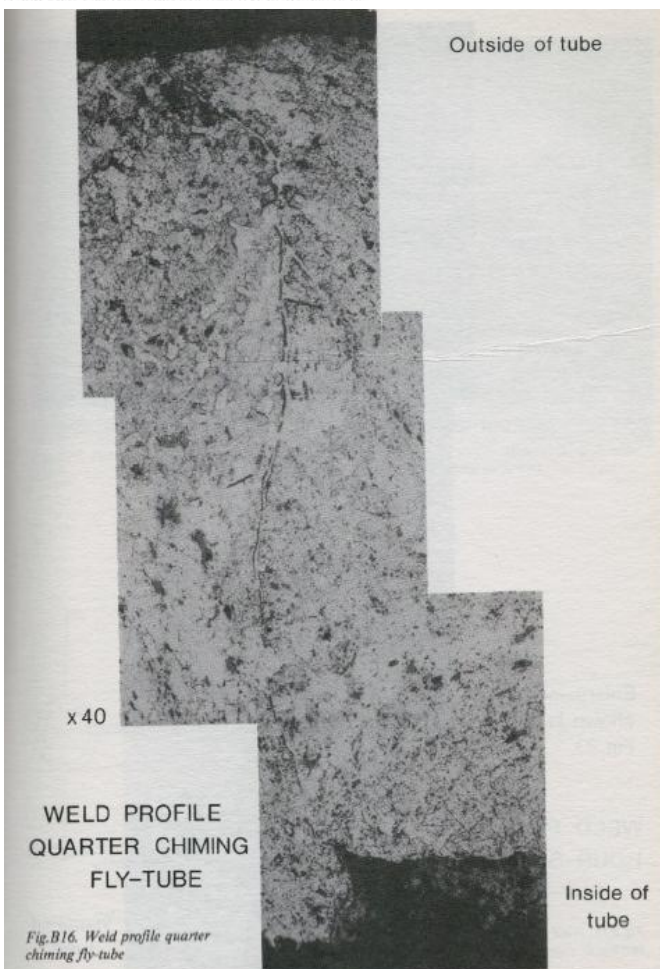
Fig. 3c. Cross section of chime tube butt weld at 40x magnification.

This was filled with slag and was probably formed during the welding process when the surface material on one side of the joint was forced to flow past that on the other side. The root of the notch lay along the line of the weld, which can be clearly seen in *Fig. 3c*. The weld line was marked by a region of differing etching characteristics, probably caused by higher concentrations of oxygen and other impurities at the weld. The weld joint coincided with a plane of maximum shear stress, and as seen in the photo above, the crack followed the line of the weld across the tube wall, joining the notch at the inner surface to a similar notch (though less evident) at the outer surface of the tube.

So examination of the chime fly tube shows that the way the tube was manufactured, using a butt welded seam, and to a lesser extent some manufacturing and materials quality control issues, directly contributed to the failure. It was an unfortunate coincidence that the maximum shear stress for the butt weld would be present along its weakest, which is longitudinal, profile. To be fair, this was before the advent of seamless tube manufacture. In addition this type of tubing was generally used in water and gas piping which would not present the types of shear stresses to the butt weld seam. In this application the tube was called upon to perform structural duties for which it was not suited. The presence of the weld seam, through which the crack had progressed masked the crack which may have, in the absence of such camouflage been discovered prior to the accident.

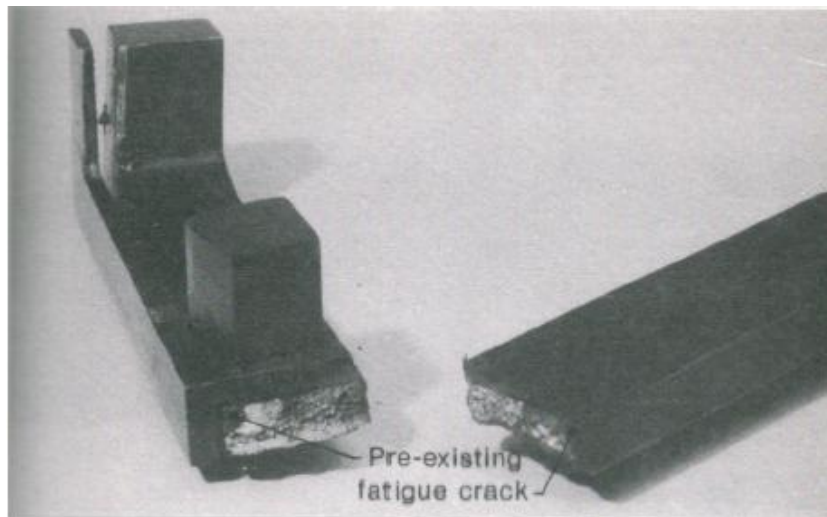
Fig. 4a. Chime locking lever, fractured end piece.

The head of the wrought iron locking lever was broken off. The main fracture appeared to be caused by impact but the fractured faces contained a zone of fatigue damage which no doubt existed prior to the final failure, (Fig 4a). The tail of the locking lever was bent and damaged locally from impact, and its drive shaft bent at the lever end, (Fig 4b).

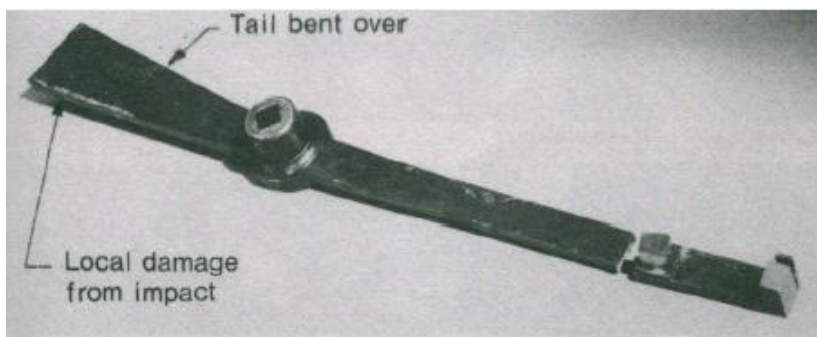
Fig. 4b. Chime locking lever, overall view showing bent counter-balance tail.

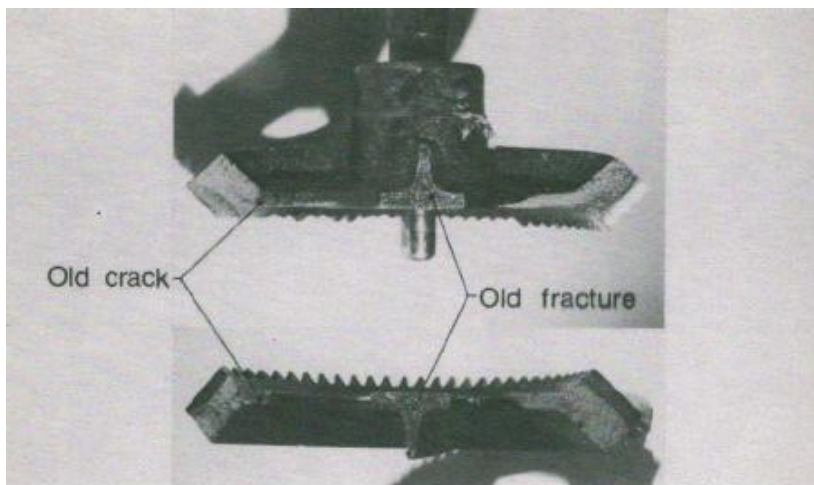
Fig. 5a. Chime fly shaft bevel showing pre-existing damage.

There was an old fracture in one of the four spokes of the cast iron bevel wheel on the fly shaft, (Fig 5a) and one other spoke also contained an old crack. The teeth on the fly shaft bevel were damaged consistent with that expected from the mating gear wheel on the drive shaft if it were partially engaged, (Fig 5b).

The bevel wheel attached to the fly shaft which already contained fractured spokes, (Fig 5a), probably broke during this stage by jamming the bearing bracket or drive shaft. The failure of this bevel occurred early in the train of events because the portion of the wheel broken off was lying more or less directly under its position in

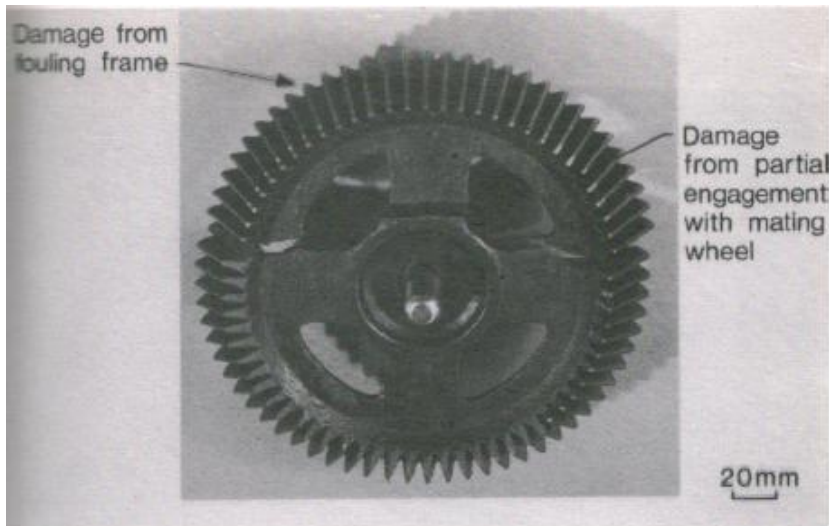
Fig. 5b. Chime fly shaft bevel reconstructed showing tooth damage from partial engagement.

The damage to the bottom fly shaft bearing and witness marks on the teeth of the bevel wheel, (Fig 5b) suggest that the lower section of this shaft tilted over during the failure. The damage to the teeth of the bevel on the drive shaft, (Fig 6) and *marked 'B'*, indicates that this wheel was stationary while the partially engaged mating wheel on the fly shaft was still rotating, presumably under the inertia of the displaced fly on the bent fly shaft, which would have disengaged from the upper bearing at this stage and been partially supported by the steady. This implies that the striking mechanism was stopped and held by the locking lever, *marked 'C'*, and that the damage to this wheel followed the striking of the 3:30 AM chimes.

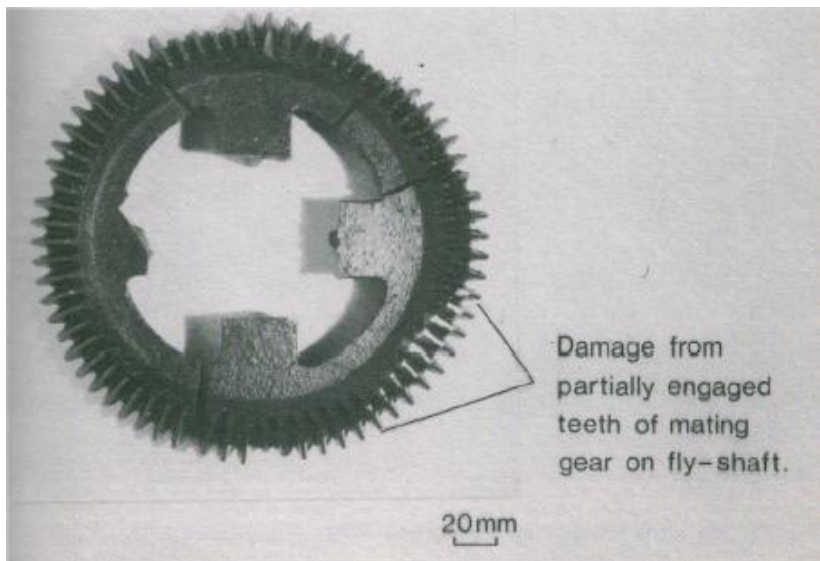
Fig. 6. Chime drive shaft bevel showing tooth damage from partial engagement.

The damage to several of the drive shaft bevel wheel teeth was consistent with that expected from the mating gear wheel on the fly shaft if it were partially engaged, (Fig 6).

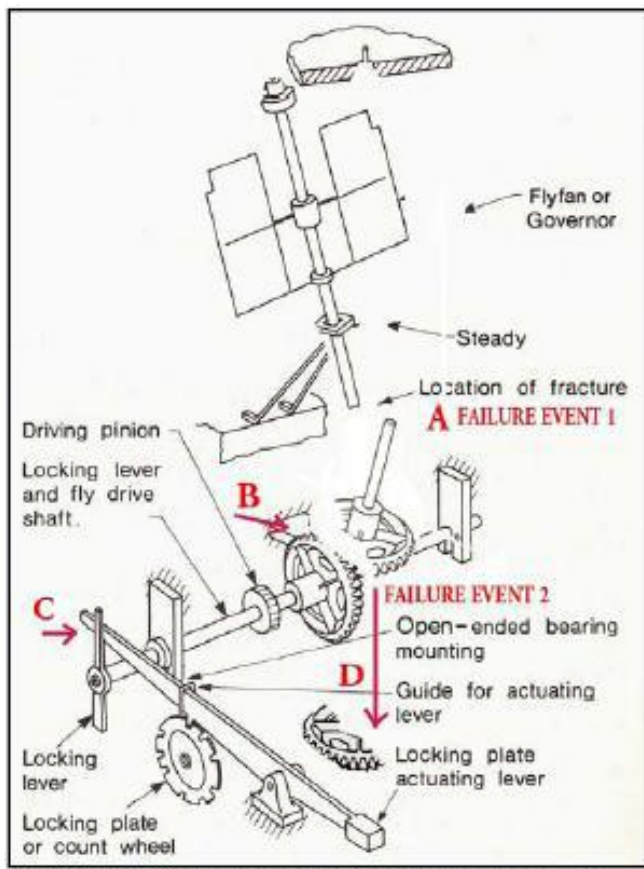
Fig. 8. Fly governor mechanism after 3:30 AM chime

(Fig. 8). The observed crack in the welded seam of the tube element of the fly shaft probably originated at its lower end, *marked 'A'*, where it fitted onto the shaft which carried the bevel wheel used to transmit the drive through the tube. Slow propagation of this crack, within the welded seam along the length of the tube, may have taken place during a substantial portion of the life of the clock. *As noted earlier, this fatigue crack resulted in the failure of the fly shaft.*

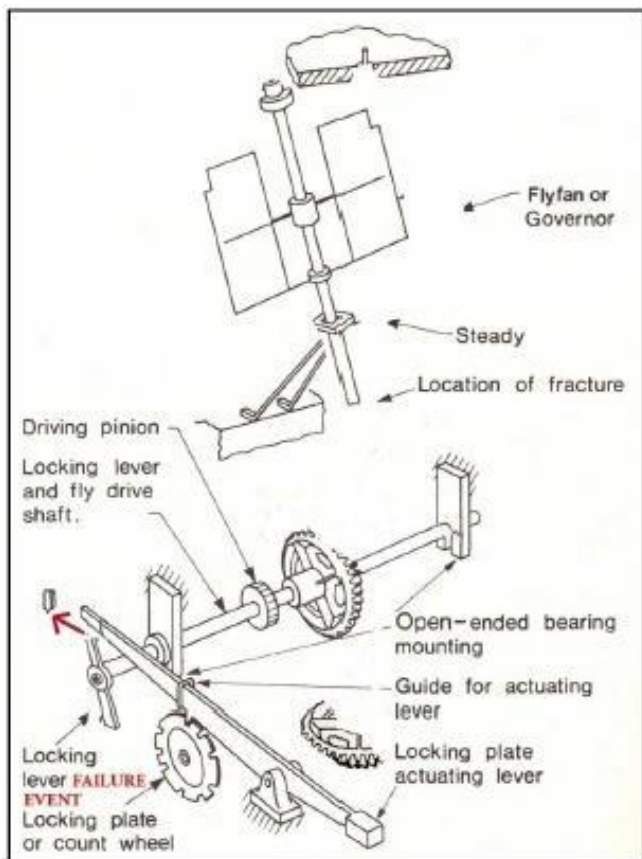
the clock with its teeth relatively undamaged, marked 'D', also see (Fig. 2; illustration in photo marked a). With the bevel wheels disengaged and without the restraint of the fly governor, the drive shaft when next released at 3:45 AM, would have been able to increase its speed of rotation. When the locking plate actuating lever attempted to stop it, the locking lever could have struck it with sufficient force to break off the end of the locking lever, particularly since it already contained a fairly sharp mechanical groove from which a fatigue crack, (Fig. 4a), had emanated, (Fig. 9).

Fig. 9. Governor mechanism post 3:45 AM strike, event 1.

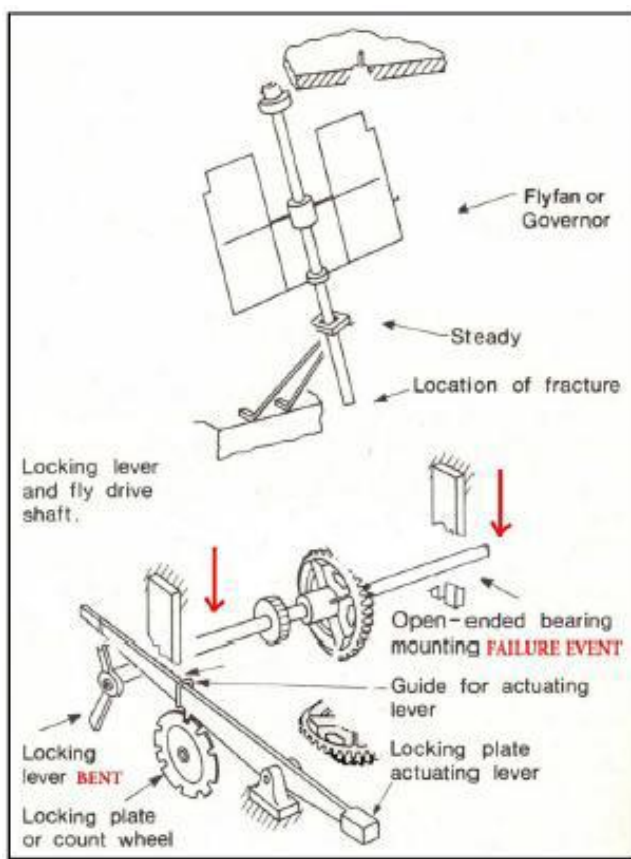
The bearings for the locking lever and fly drive shaft, which shaft was bent at one end, were mounted in cantilever brackets integral with the cast iron clock frame. These brackets were open at the end to enable the shaft assembly to be mounted as a unit in the clock frame. The fork end of both brackets had been snapped off at their minimum section across the bearing diameter, and the fracture surfaces were all indicative of brittle failure. The minimum section of the fork end of the bracket nearer the fly shaft gearing had been reduced further by the addition of two holes tapped for screws to retain the bearing, and the plane of the fracture ran across this reduced section through the centers of the holes, (Fig. 10).

Fig. 10. Governor mechanism post 3:45 AM chime, event 2

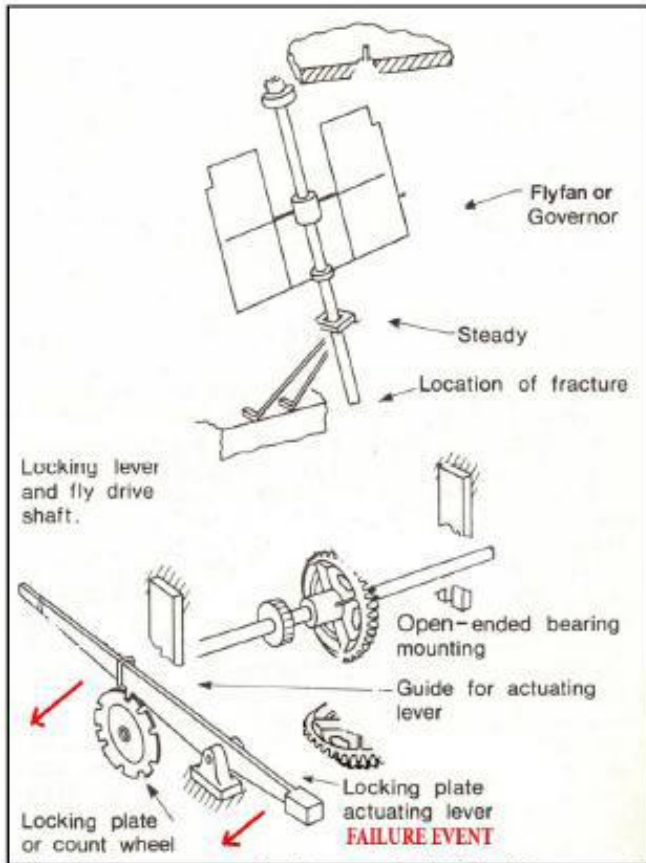
With the fly governor and locking constraint removed completely the release of potential energy from the driving weight at 12.5 kN at 40 m (1 ¼ ton/f at 132 ft)*¹ forced the mechanism to operate at speeds in excess of design limits. The single pulley arrangement used on the driving weight would result in the cable unwinding from its drum at twice the velocity of the falling weight. These excessive operational speeds would be expected to lead to parts of the clock mechanism breaking loose and to breakup of the cast iron frame. Early in this train of events the jamming of the quarter bell striking levers on their operating cams, which were designed to operate slowly, would be expected to have imposed sever dynamic impact loading on the frame and mechanism until some of the levers and cams broke, and this section of the frame broke away.

Fig. 11. Governor mechanism post 3:45 AM chime, event 3

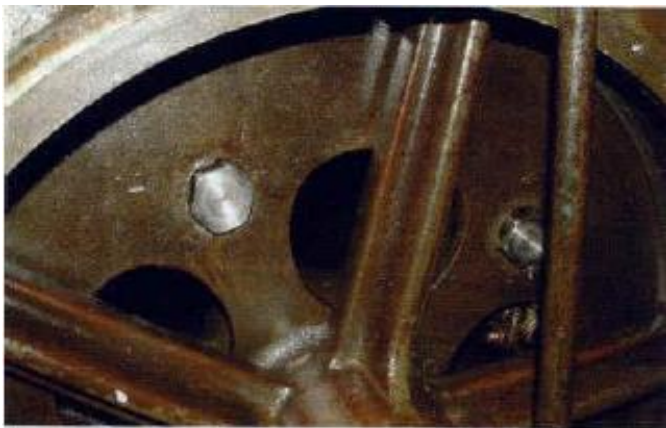
1. Rear view of hour strike barrel. Bolt heads were rubbing.

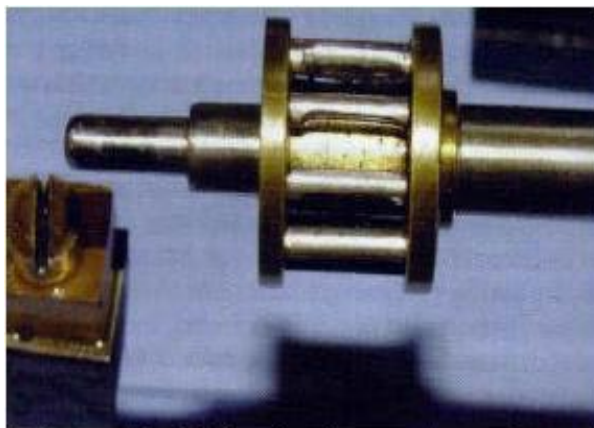
Almost exactly 30 years later in August 2007 the clock went through an extensive maintenance program to be sure it would be in top condition for its 150th anniversary. Why was an extensive restoration needed? Wear had been noticed in the striking train where the strike barrel was seen rubbing on the great wheel during winding, **Photo 1**. On the going train the lantern pinions trundles on the escapement arbor were getting deeply worn, **Photo 2**.

2. Escape wheel pinion, showing wear on trundles.

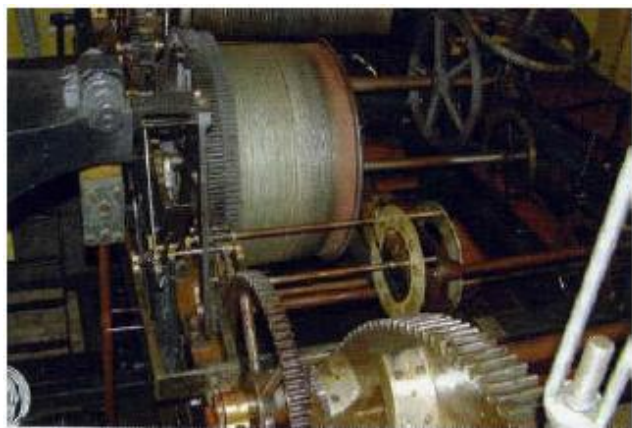
3. Movement view. Note replaced bronze strike wheel and cams.

In **Photo 3**, notice in the lower right the portion of the quarter strike train that was replaced after the accident in 1976. It was remanufactured in bronze to avoid the types of fractures that plagued the original cast iron material. Ian Westworth, Paul Robertson and Huw Smith are the three Palace clockmakers, **Photo 4**. Apart from making three visits a week up the tower to the clock for maintenance and winding, they are responsible for winding, servicing and repair of the over 1000 clocks in the palace as well. Some of you with large clock collections thought you had a lot of winding and repair work! Six to eight weeks were allocated for the work. Since it was decided to keep the hands telling time, an early task was to specify a synchronous drive unit that would neatly fit next to the bevel wheel cluster. A special unit was commissioned, **Photo 5**, next page, built and tested at full load.

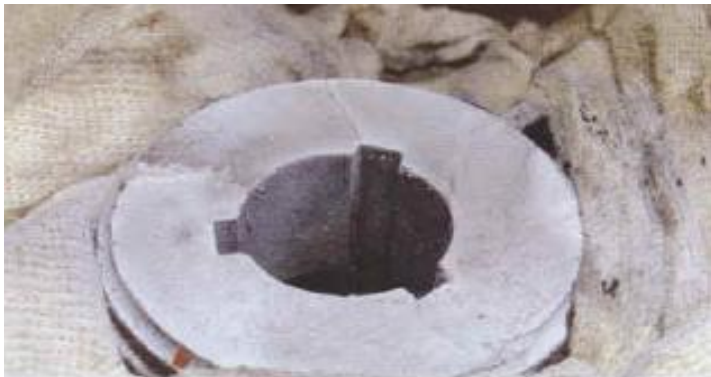
An inspection of the going barrel's arbor keyed collet revealed more of the dreaded stress cracks. These were mated to tapered keys that were on the arbor and originally hammered into place to secure the assembly, **Photo 15**. The crack was repaired with a method called 'cold stitching', a technique used to repair castings. A series of holes is drilled using a custom jig, the series of holes being at right angles to the crack, **Photo 16**. A specially shaped lock insert is put into the hole and secured with a resin. The lock is made from a high nickel steel alloy and is much stronger than the surrounding cast iron.

15. Cracks in going great wheel hub.
