British Horology Times

Another Family Heirloom!

By Dennis Radage (CAN)

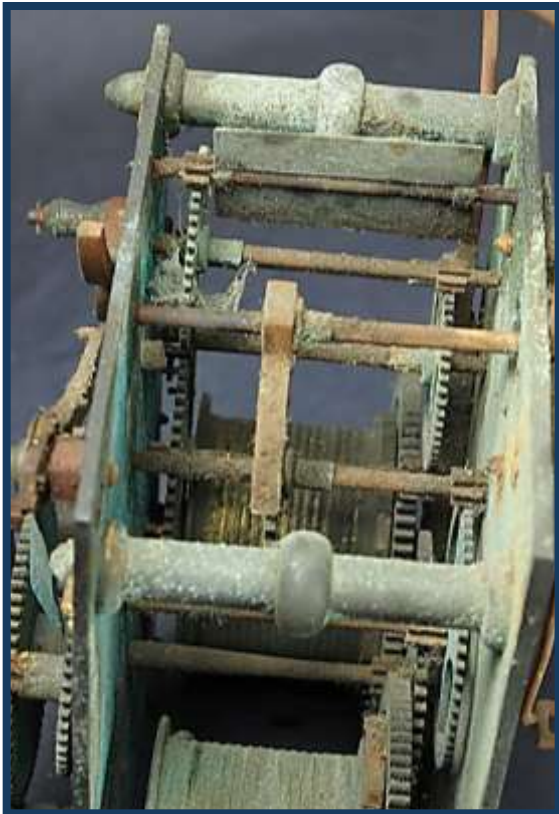
Figure 1: The "Heirloom" as received

The clock arrived, nicely packaged. Opening the package however, exposed something that I was not expecting. Figures 1 through 3 show the movement as received. This is possibly one of the worst cases I have seen of gross neglect. As can be seen from the different images, all brass parts, plates, pillars, wheels, collets and drums are suffering badly from corrosion, in this case “bronze disease,” which is the greenish coppery powdery coating covering all parts. Left untreated, all brass parts would eventually disintegrate.

The brass rack return spring had indeed disintegrated. All steel and iron parts were badly rusted. The pivots have also rusted, some had broken and others were “frozen” in their pivot holes. Adding to the unexpected were cobwebs and layers of dirt that had bonded itself to the metalwork. The owner, I am sure, was quite unaware that this was not the normal condition for a stored clock and that simple cleaning and lubrication would not salvage this clock!

After dismantling, each component was individually brushed, using a brass bristle brush, to remove as much of the dirt and loose corrosion residue as possible. I then use a soak in hot water to initially treat the brass components.

Bronze disease is first treated by a long soak in very hot water, usually 6 to 12 hours or more. Of course, the water needs to be kept hot and possibly changed several times.

After this treatment practically all of the bronze disease can be brushed off, again using a brass bristle brush. At this point it is possible to recognize that all parts are indeed brass.

I then use conventional clock cleaners to finish the job. Since I avoid removing brass, I do not use any other mechanical means to clean the brass.

The brass will be bright but is usually pitted where the corrosion had eaten into the surface. This pitted surface remains and therefore becomes a part of the clock's character and history.

I generally avoid rust removers, but in this case I must admit that I did soak the iron and steel components in such a solution. I also used a "000" grade wire wool on these parts to remove the worst of the rust residue and to add some brightness to the iron parts. As with the brass parts, the iron parts were left with a somewhat pitted surface. I know that some would prefer not to leave the parts in a pitted condition, but when fully assembled, the movement has some character, and there will always be a story to tell as to the history of the movement.

At this point each component is individually inspected and needed repairs are carried out in the normal manner. Pivots are replaced, and any missing or broken/damaged parts are also replaced or made. The movement is then assembled, new line is added, and then the movement is lubricated and placed on the test stand (Figure 4). Adjustments are made and the clock is put in beat and then run for about two weeks while being rated and making any additional adjustments to assure reliability and correct functioning.

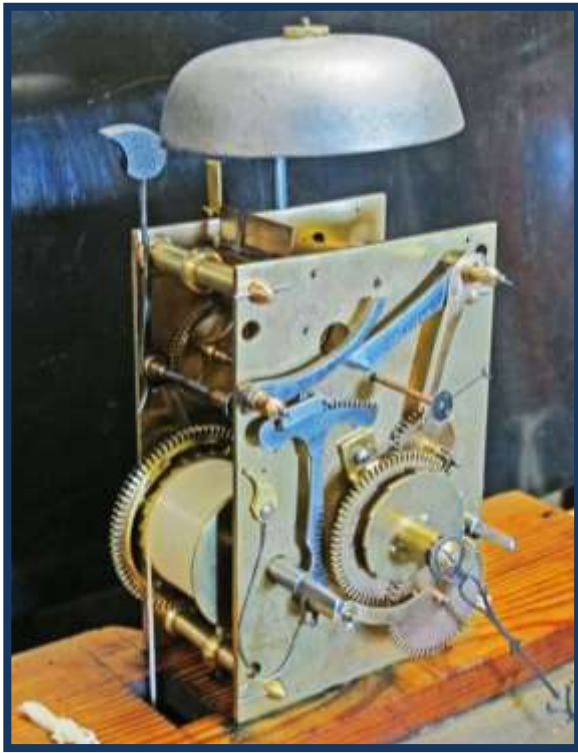
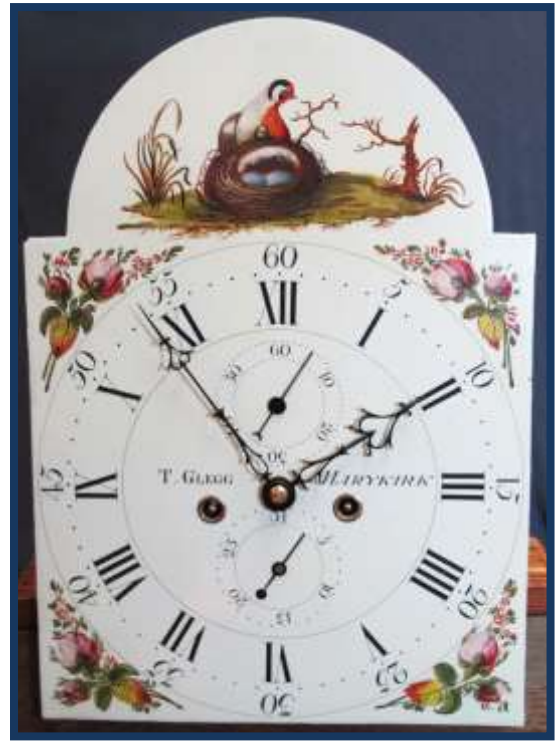
Figure 4: The finished job; (left) the restored movement is assembled and functioning on the test stand and (right) with the restored dial attached.

The dial restoration can take anywhere from 4 to 6 weeks. Utilizing an experienced expert for this work ensures that the job is always well done and the finished dial is an asset to the clock (Figure 4).

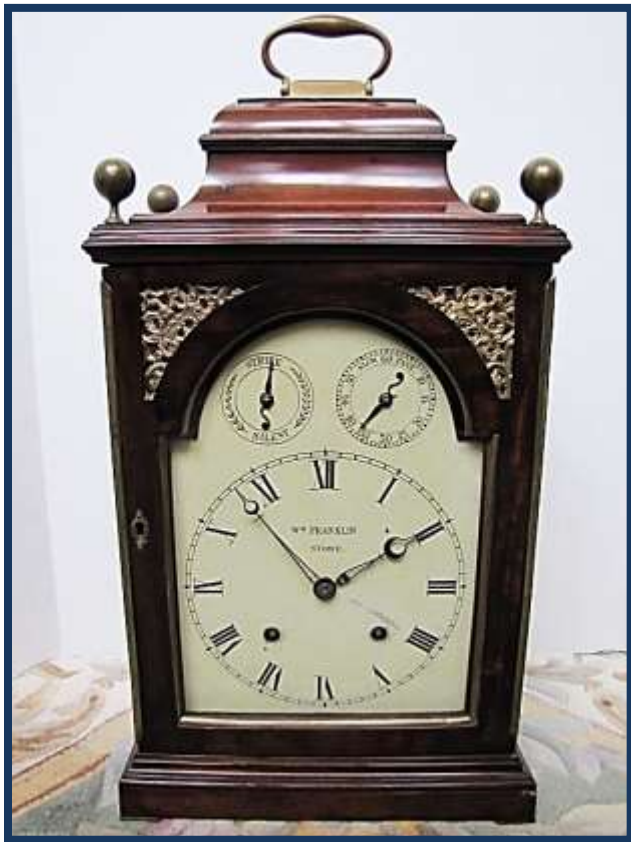
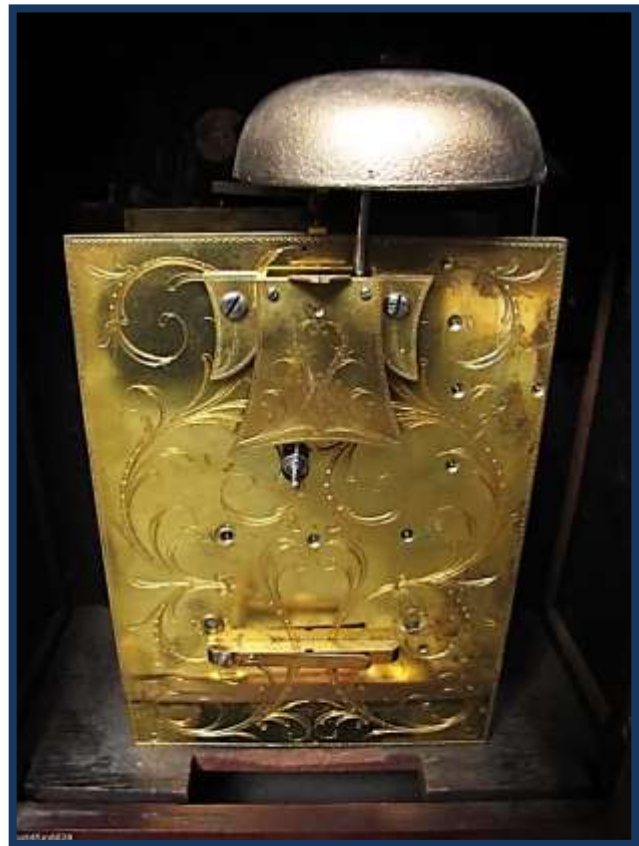
The clock was acquired online based upon two photographs that showed the case and the back plate of the movement (Figures 1 & 2). The case appeared to be a 1780-1800 elegant and rather austere bell-top example with a painted dial signed William Franklin, Stowe. At the top of the dial are two subsidiary dials; the one in the left upper corner indicates strike and silent, and the second, in the right upper corner, displays a rise and fall indicator to assist in setting the accuracy of the timekeeping. Interesting, and unusual for an apparent English bracket clock, is the position of the low winding arbors that indicated that the movement lacked fusees. The back plate is nicely engraved with typical 18th century quality engraving. The online photographs, with the bell in place, concealed any further details about the moment or escapement.

Figures 1 & 2: Dial and movement of unidentified bracket clock, circa 1780 - 1800

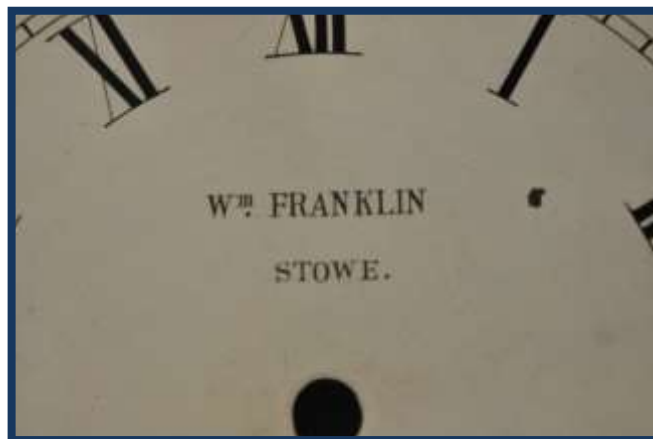
Next, I turned to the name on the dial, William Franklin, Stowe (Figure 4). Unfortunately, "William Franklin" does not exist in any of the standard clock maker reference books. There are several towns named "Stowe" in Pennsylvania, Vermont and also in England. However, pin wheel escapement bracket clocks are extremely uncommon. There is at least one well-documented example of a Philadelphia pin-wheel bracket clock by the renowned American maker Thomas Parker that has very similar features to this clock including going barrels (no fusee) that dates to about 1820 (J. Carter Harris, *Pennsylvania Clocks 1750-1850, A Special Exhibit of the National Watch and Clock Museum*, Columbia, PA, 2002).

Figure 4 (top): Close-up of dial signature.

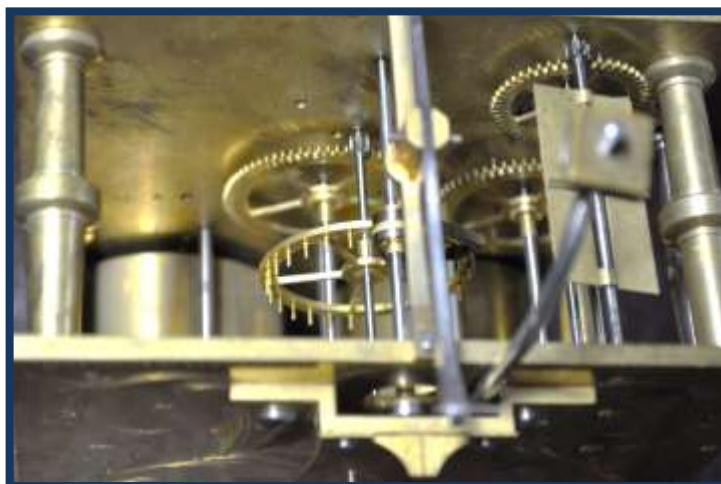
Figure 5 (bottom): Close-up of pin-wheel escapement.
