The Howard Banta Alarm Clock Chapter

Chapter 178 of the National Association of Watch and Clock Collectors

2007 Volume 4

The Baby Ben Movement Restoration Highlights

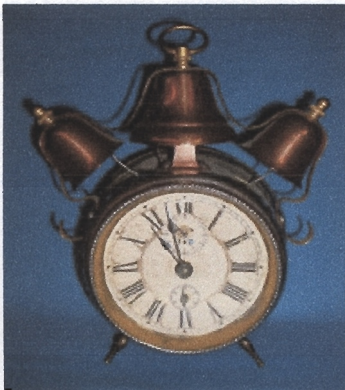
In April of last year I was in the Black Forest. A French trader brought me an alarm clock from Mauthe, Villingen-Schwennigen. I'd been searching for this model for a long time. It was expensive, but I'm very glad to have found one. You would recognize this model as there was one in the Howard Banta collection. The piece is complete and in original condition with a decoration over the bells.

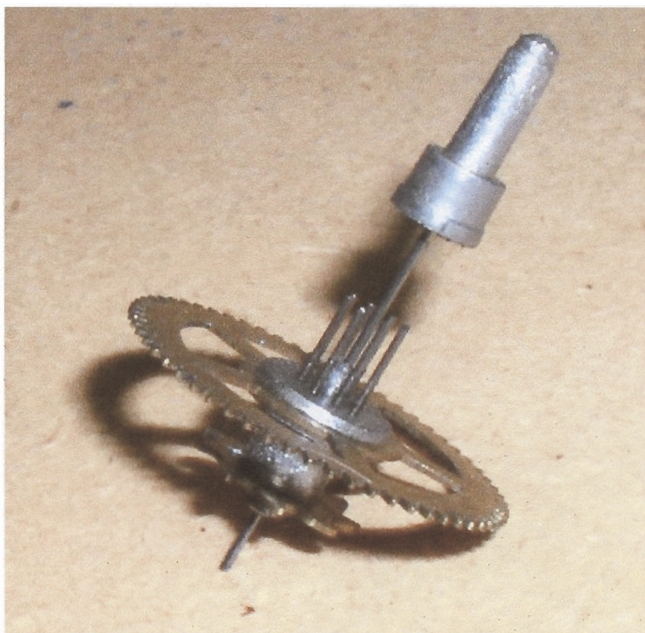
Cast Arbor and Pinion Problems (Westclox products). Many Westclox cast arbor components develop faults over the years. Pictured below is an example.

To the left is an example wheel with a broken internal arbor.

Internal cracks weaken the arbor and at the extreme will cause gearing problems due to the deflection of the arbor. The telltale sign is that the pinion will split apart if gently pulled. Such damage is unacceptable and must be dealt with. The easiest and most efficient solution is to replace the whole wheel. If this is possible, by all means do so. The other means is to repair it. The type of repair will depend on the type of damage, where in the arbor it occurs, and its effect on its performance in the clock. The methodology for repairing these wheels is beyond the scope of this article, as it requires a proficiency in machining that cannot be assumed. Feel free to contact me if you wish to discuss such repairs. JB Weld has been used with some, but limited, success.
