The Howard Banta Alarm Clock Chapter

2007 Volume 3

The Baby Ben Movement Restoration Highlights

by Ken Reindel*

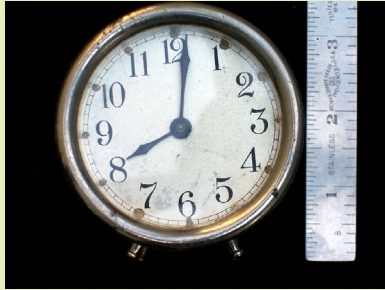
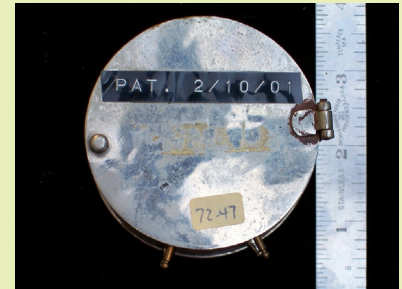
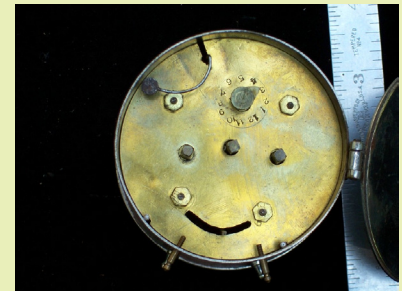
I'm hoping one of you may help to identify the alarm clock I've shown here. Its a key wind, apparently of rather high quality. The back (upper right) opens to give access to the alarm set.

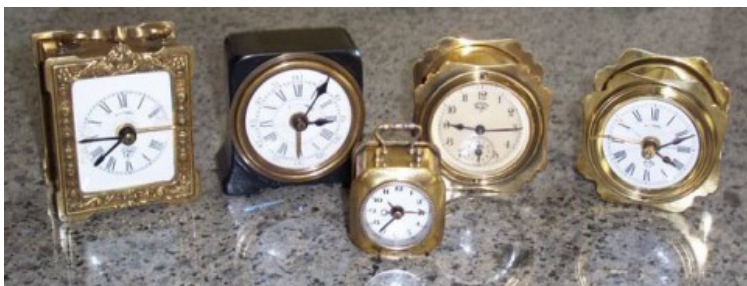
A few of my alarms are shown below. In the long image with five alarms, three are pendulum driven. From left to right:

- (1) A Lenzkirch with pendulum. This has a signed dial and movement.
- (2) An unsigned wood cased movement with pendulum. This appears to be basically identical to the Gustav Becker with pendulum
- (3) A subminiature alarm with balance wheel. The case is signed DRP. The movement is unsigned and has a tandem wind -the first I've ever seen in an alarm.
- (4) Gustav Becker with balance wheel and signed dial and alarm.
- (5) Gustav Becker with pendulum and signed dial and alarm.

The 3 alarms with pendulums have no alarm or time setting knobs and are set by moving the hands which are not glass covered.

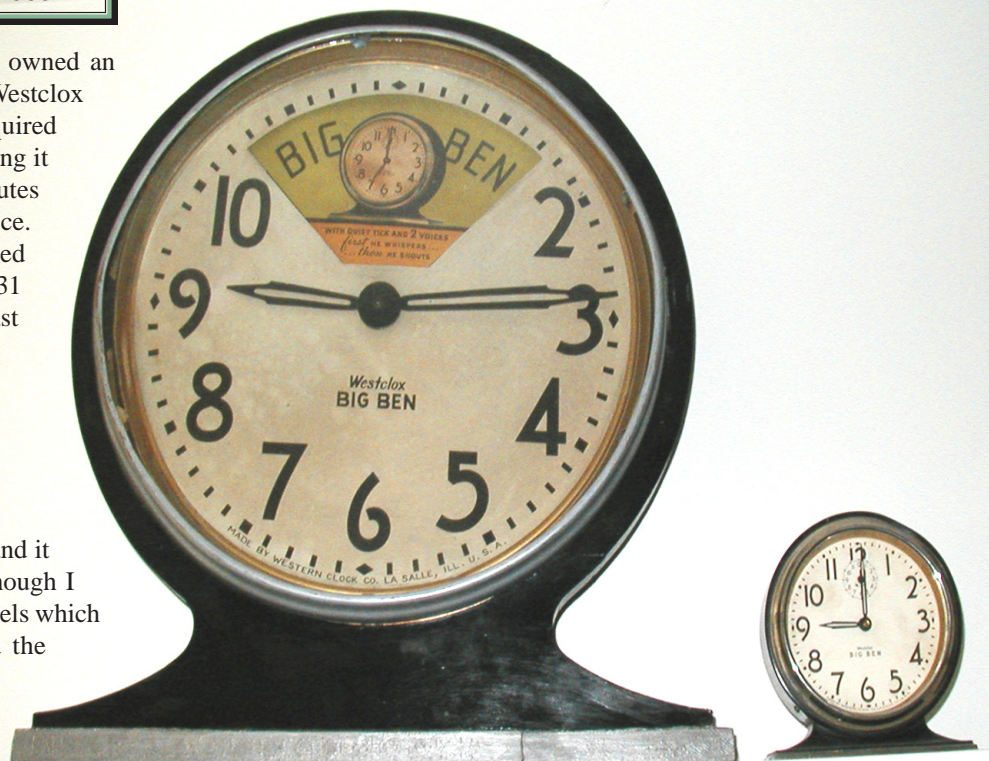
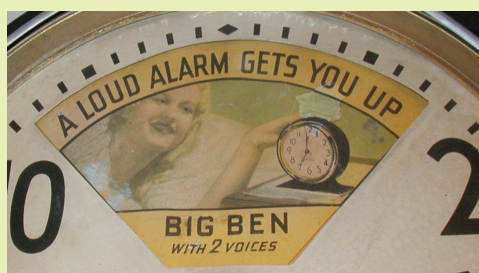
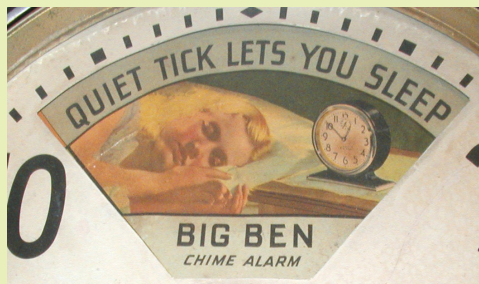
Several years ago a friend of mine who owned an antique shop contacted me concerning a Westclox Big Ben advertising piece that he had acquired and asked if I would be interested in buying it from him. I was on my way a few minutes later and very pleased when I saw the piece. It is made of 3/4 inch plywood and shaped exactly like the Big Ben Model of about 1931 which has printed on the bottom of the cast

Needless to say I bought it immediately and it did require some degree of restoration though I am very reluctant to do too much. The panels which rotated beneath the dial and advertised the clock had some wear and in places missing pieces of paper which I did touch up but other than that it was intact.

The pictures display the four different advertisements that appear as the clock operates. The drive motor is an early Seth Thomas which requires the moving of a lever to start the motor. It had not run for ages and I did do some necessary maintenance on it and it ran quite satisfactorily after that. The back of the display has a label from Schloss Manufacturing Company, 523-525 Mission Street, San Francisco and typed on the label is Display #65 Property of Schloss Mfg. Co., San Francisco. I have not been able to find any information on that company but would like to hear from anyone who knows of it.

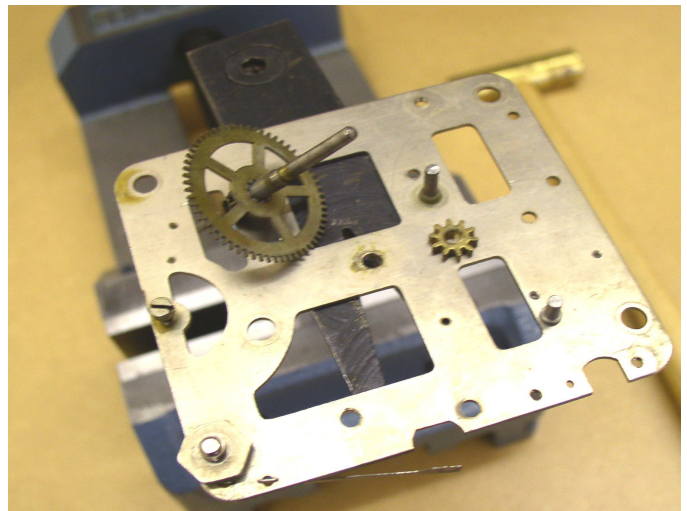
Pinion Removed (Style 3 Chime Alarm)

As you can see on the left above, the center wheel cannon pinion has been removed. Often repairers skip this step and leave the pinion in place because it is considered difficult to remove. In fact, it is not difficult to remove with the right tools. Below is a picture of our setup. A few brisk taps with a light brass hammer and the assembly slips apart easily. Getting under the cannon pinion is very important. Cleaning and servicing this hole cannot be done any other way. In this case, we also had to deal with the badly marred center wheel arbor which had been staked flat, distorted, bent and scratched in some previous repair operation.

The small Palmgren vice shown in the background is a "must-have" on the clockmaker's bench. It is one of the most handy, helpful tools on the bench. It is heavy enough to be used for staking operations, but light enough to be moved where most convenient, even as a milling or drilling vise! It's one of the most frequently used tools in our shop.

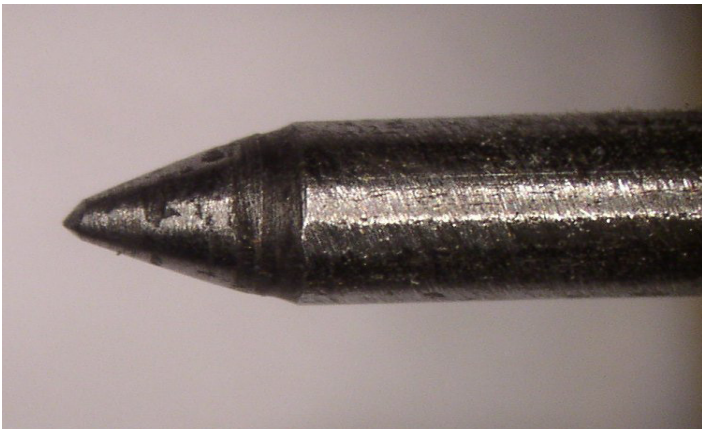
Balance Wheel and Balance Cups. The balance wheel pivots are the most common source of frustration for the alarm clock restorer. If worn (and they are the majority of the time) and left unattended, the clock will run sluggish and stop before fully unwound. Severe friction between the balance wheel pivots and cups can stop a clock. The balance wheel pivots can be resharpened and burnished on the lathe. Cups with minor wear can be re-used. Cups with deep wear from years of running with bad pivots will need to be replaced. See pictures below.

An example of a worn balance pivot, highly magnified. Note the flat spot on the upper tip of the conical pivot.
