# The Howard Banta Alarm Clock Chapter

2008 Volume 3

## **Restoration of Darche 1908 Flashlight Alarm**

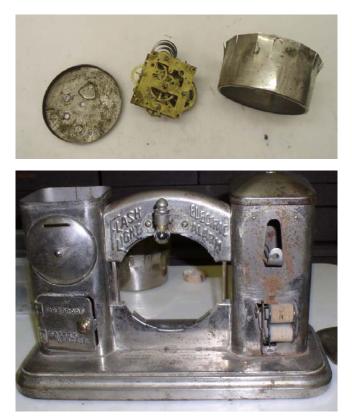
The subject clock for this restoration is shown above. In great disrepair with rust and corrosion throughout, the challenge was to bring it back to life.

Several enormous challenges with this clock are noted. First, the clock movement can is split all the way around its perimeter. It will have no part to play in a quality restoration and there is no way to repair it. A new can would have to be fabricated. Second, not quite visible from the pictures, is the corrosion resulting from

battery leakage over the years. There was not a single wire that could be reused due to corrosion, dry rot, or other problems.

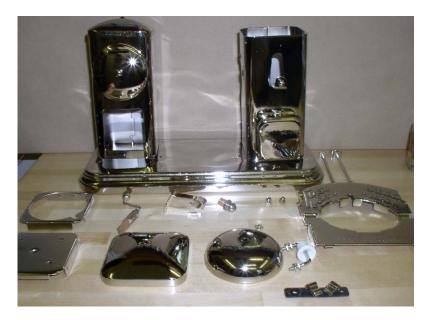
Shown below are the results of the first plating session. Another plating session completed the movement can, door and knob (which needed to be reconditioned on the lathe to restore the shape and knurl). The bank draw bar, nuts, screws, alarm winding lever, and some other small parts are likewise not shown but were likewise plated.

Some of the internal parts were badly corroded. In general, this is inconsequential as long as the corrosion is removed and none of it passes through the part. We were fortunate. All of the parts were reusable, despite clear evidence of battery leakage eating away at internal components. One hour in the nickel tank and the parts were ready to go. Every part, down to the last screw, nut, lug and gadget, was cleaned, pre-polished, and nickel plated. The nickel plating took two 14 hour sessions to complete, not including the clock can.
