British Horology Times

Repairing a Daniel Quare Spring Clock

Lesson Learned – Beware of Assumptions

By Dennis Radage (British Columbia)

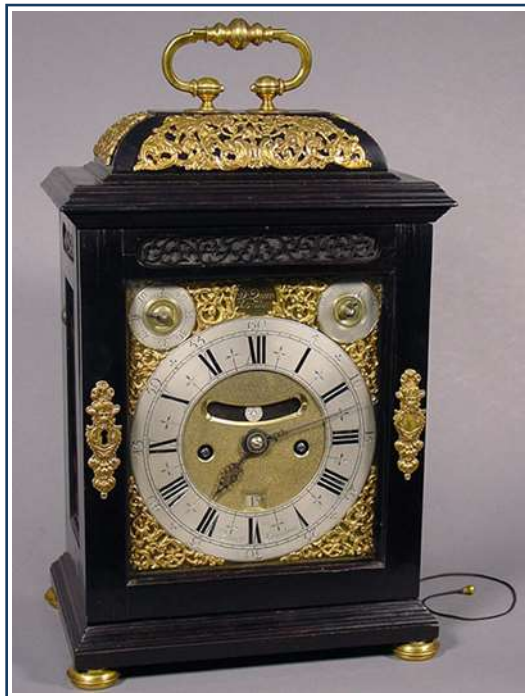
Figure 1: Daniel Quare pull quarter repeat spring clock

a minute or two. The clock, signed on the dial, chapter ring and backplate; ‘Dan. Quare London’, can be seen in Figures 1 & 2. This is a time and strike, pull quarter repeat spring clock in an ebony-veneered case with a gilt-decorated dome top. The case has open fret to the top front door rail allowing the strike and quarter repeat to be clearly heard.

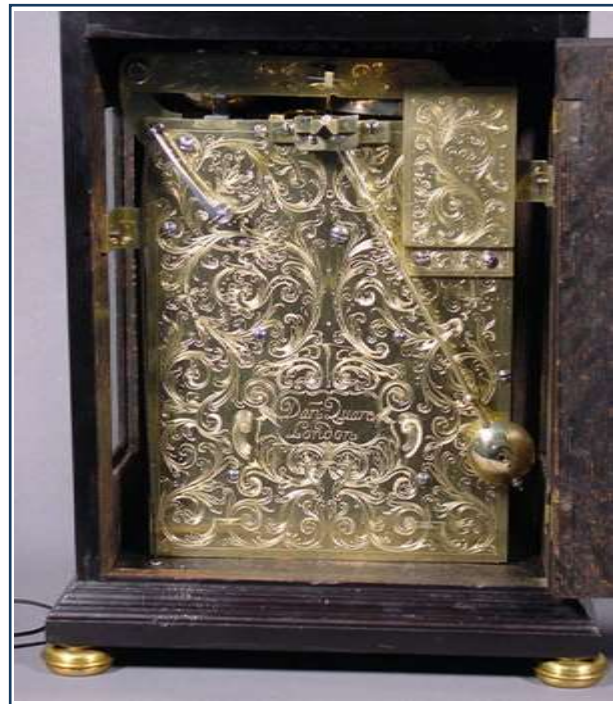
Figure 2: Decoratively engraved and signed backplate

Figure 2 (Page 1) shows the decoratively engraved and signed backplate, the short pendulum and the engraved cover of the rack and pinion rating mechanism.
