British Horology Times

A Brief History of the Great Clock at Westminster Palace Its Concept, Construction, the Great Accident and Recent Refurbishment

By Mark R. Frank ©2008

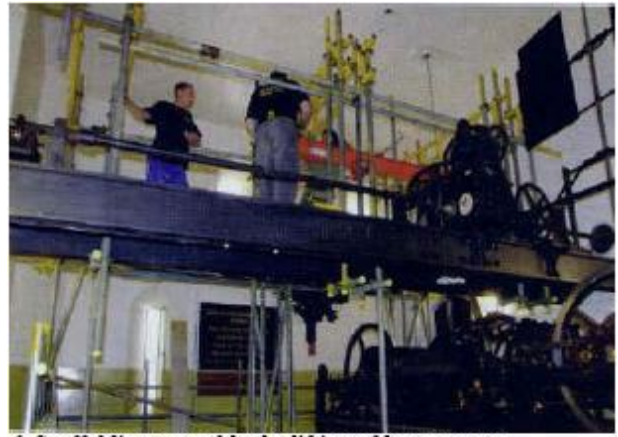
6. Scaffolding to enable the lifting of heavy parts

Before any large parts could be removed, scaffolding had to be erected around the clock, **Photo 6**. From this chain blocks were attached.

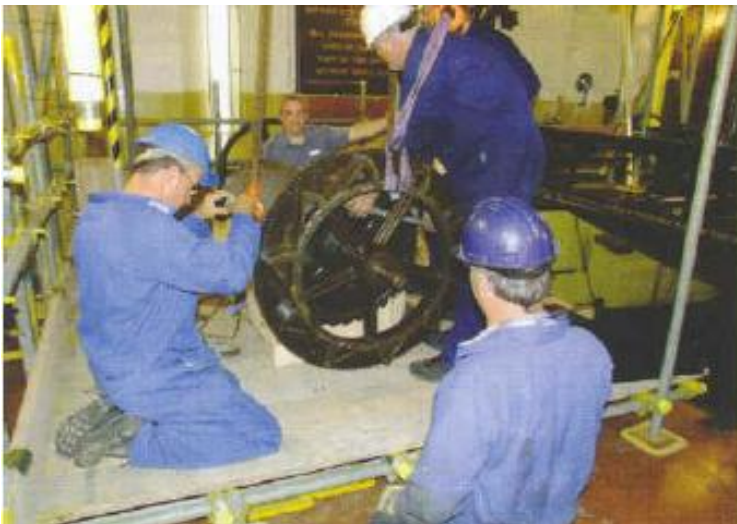
9. Safely in the cradle, the great wheel is removed from the barrel.

But before this was done, all the lesser wheels and other parts that could be damaged from a fall from the overhead scaffold structure were removed. Only then, **Photo 7**, were the main strike barrels lifted out from the mechanism. Since the main strike barrels were to be removed and brought to the ground, two cradles were made to safely hold the barrels, **Photos 8 and 9**, while workers removed the great wheels from the barrels.

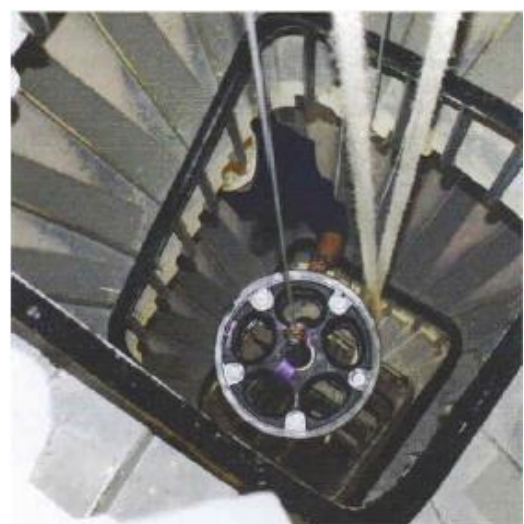
10. Strike barrel being lowered down the stair well.

This was necessary as they would not fit down the stairway shaft as a unit, **Photo 10**, prior page. The barrels were then lowered down to the ground. Remember that this was not the way the original clock was hoisted up to the tower, the original clock frame and parts were hoisted up the weight shaft which is a quite bit larger (8 x 11 feet), but is now covered by the movement itself preventing its use.

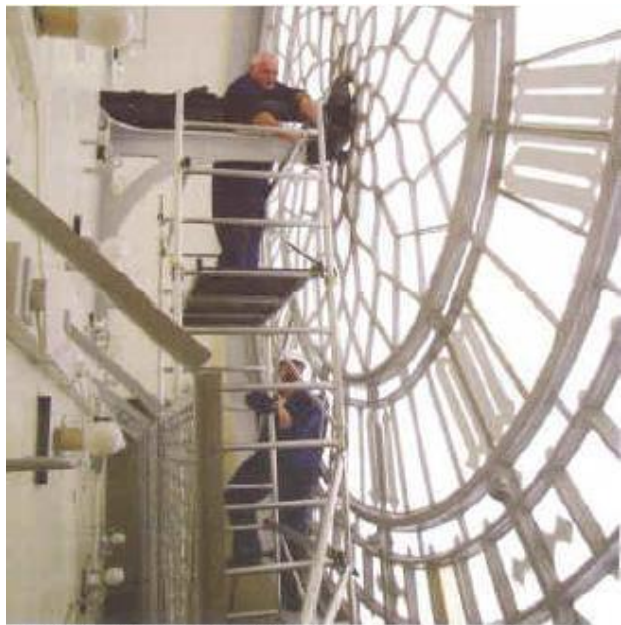
12. Scaffold to reach the 12 feet to the motion works.

Since the hour tube is about 12 feet from the floor, scaffolding was installed to reach the behind-the-dial components, **Photo 12**. The tubes reaching the hands are supported by roller wheels. There are two sets of these for each dial for the hour and minute arbors. In the past some of these rollers had seized up leading to flats on the surfaces of some of these rollers. This is an indication of the sheer power that is delivered by the movement, **Photos 13 and 14**.

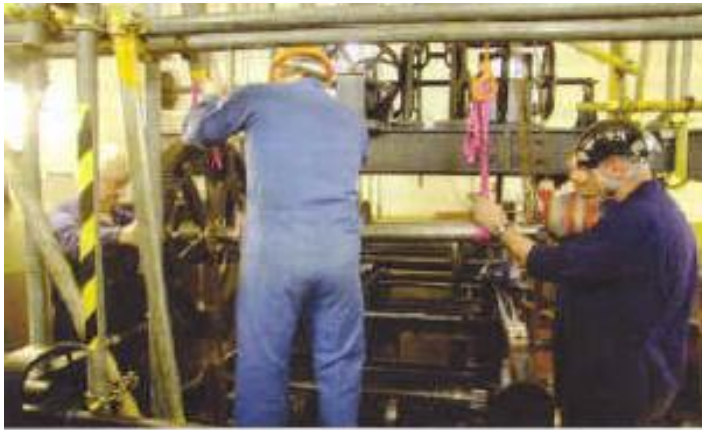
19. Strike great wheel and arbor being installed.

As the major components came back from the engineering works they were hoisted up the tower and installed; the going train first, then the striking **Photo 19**, next page. The strike barrel great wheel and arbor are first tested for true and smooth running. Afterward the huge barrel is installed and everything tested again, **Photo 20**, next page. Train and winding wheels were then reinstalled along with all the locking and release levers. Other work, on a smaller scale **Photos 21 and 22**, next page, was carried out on the escapement itself, replacing the worn lantern pinion rods.

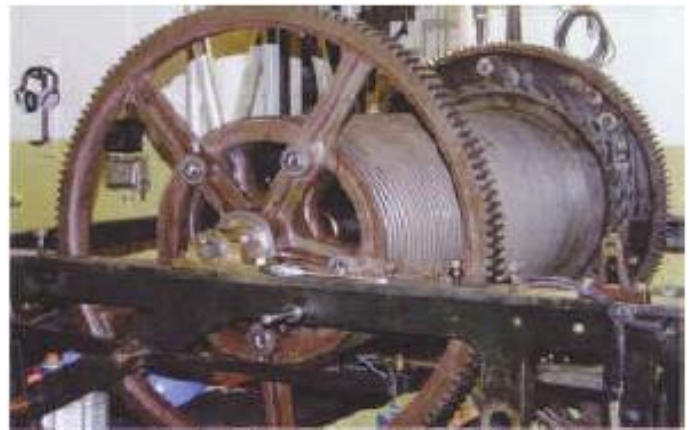
20. Strike wheel and barrel together and installed.
