British Horology Times

A Brief History of the Great Clock at Westminster Palace Its Concept, Construction, the Great Accident and Recent Refurbishment

By Mark R. Frank ©2008

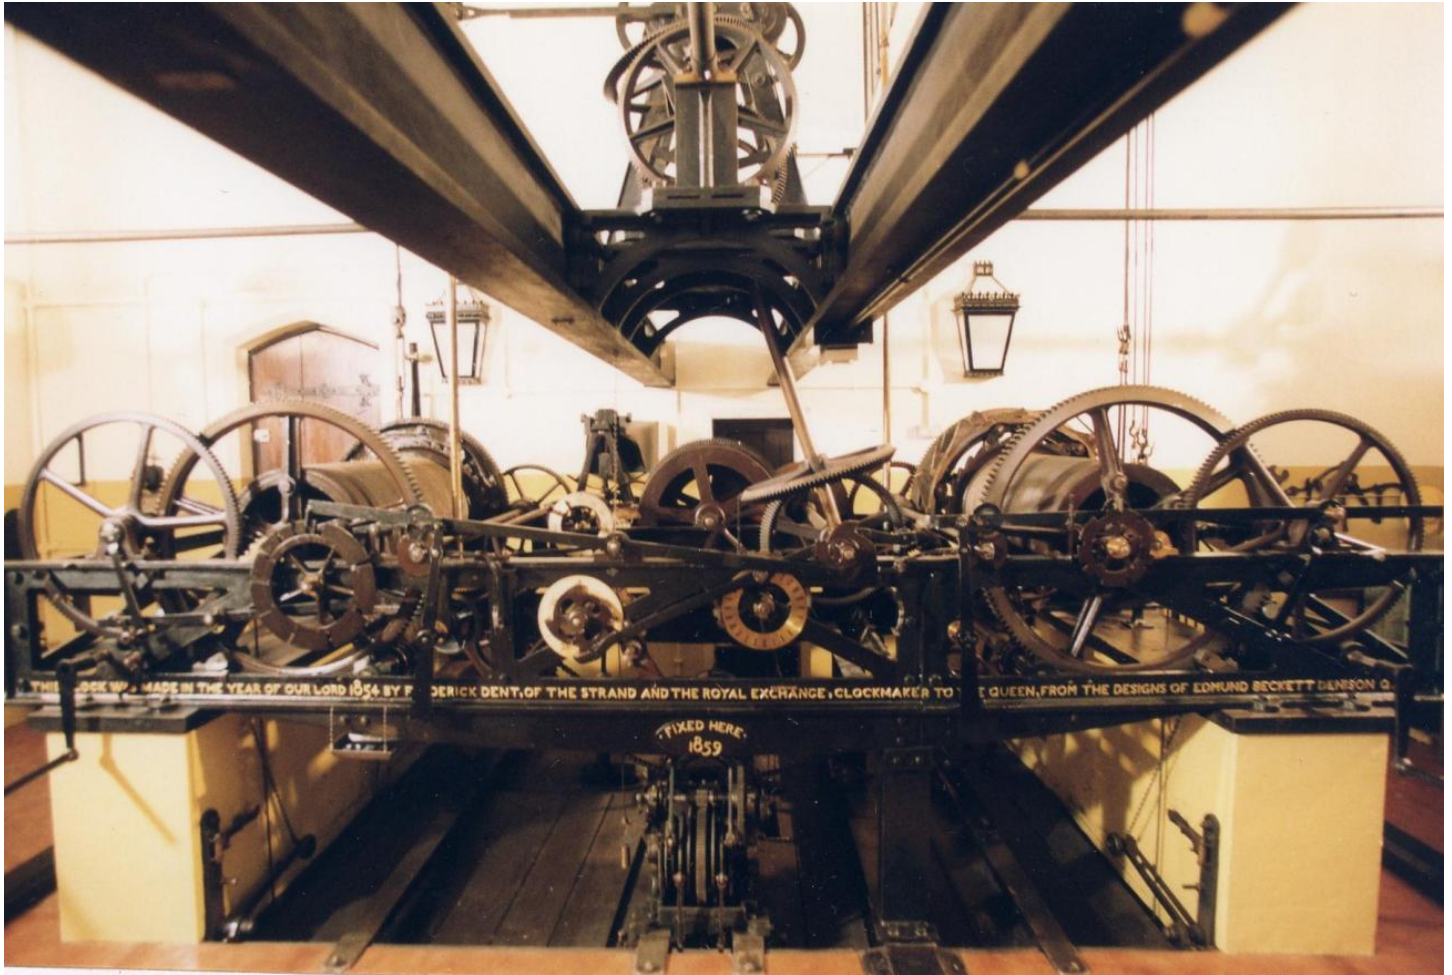
Movement as seen today

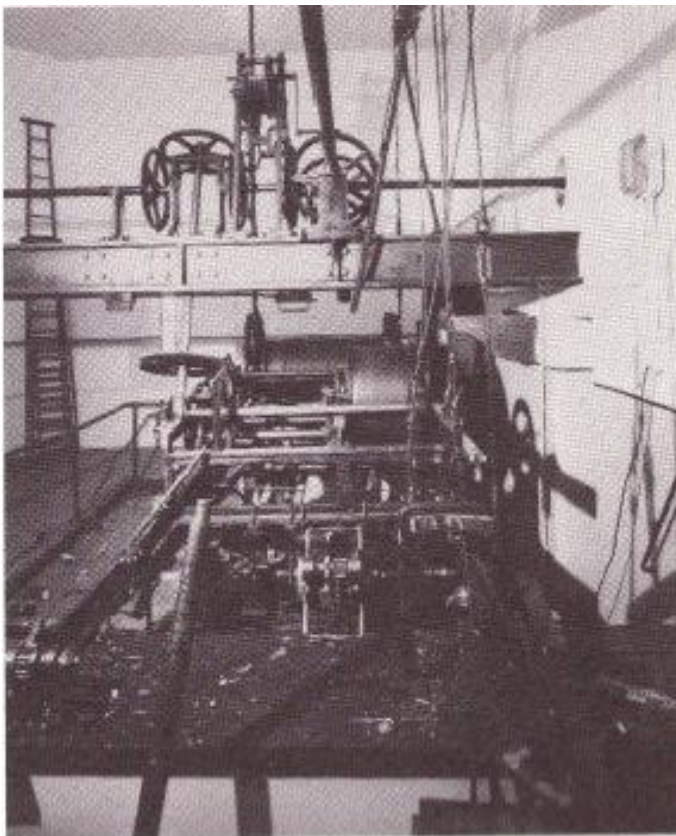
Photo 4. End view from chime side

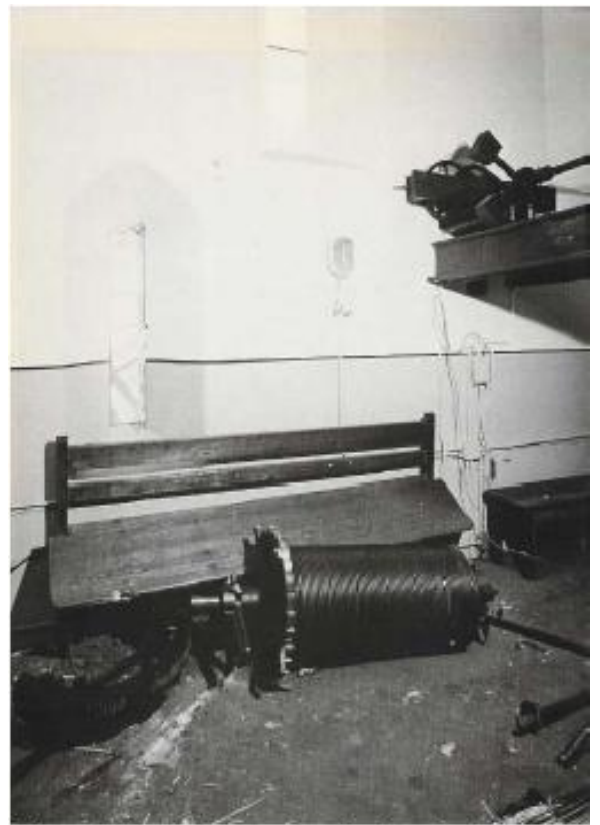
Photo 5. Note chime main wheel to the left

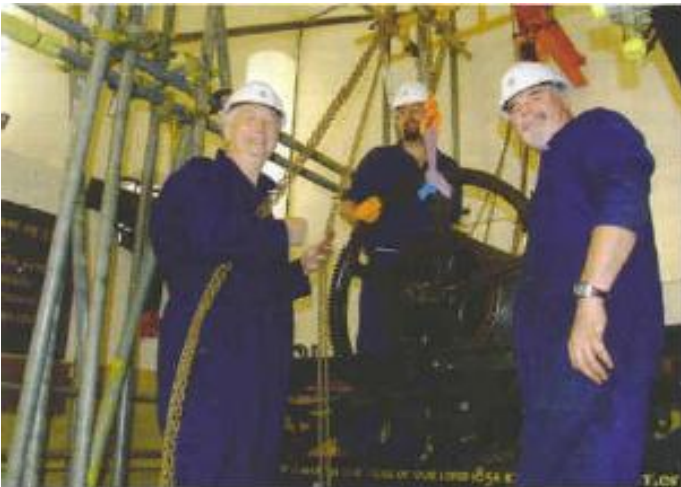
7. The Palace team lifting out the hour strike barrel

But before this was done, all the lesser wheels and other parts that could be damaged from a fall from the overhead scaffold structure were removed. Only then, **Photo 7**, were the main strike barrels lifted out from the mechanism. Since the main strike barrels were to be removed and brought to the ground, two cradles were made to safely hold the barrels, **Photos 8 and 9**, while workers removed the great wheels from the barrels.

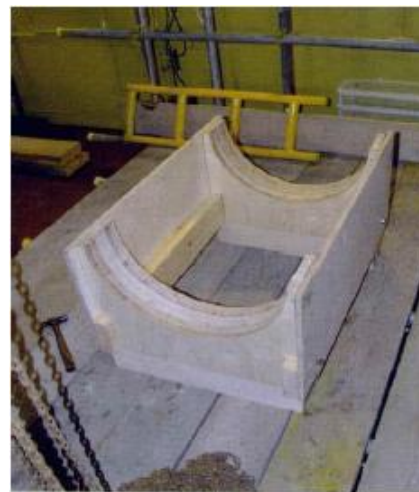
8. Cradle for strike barrel

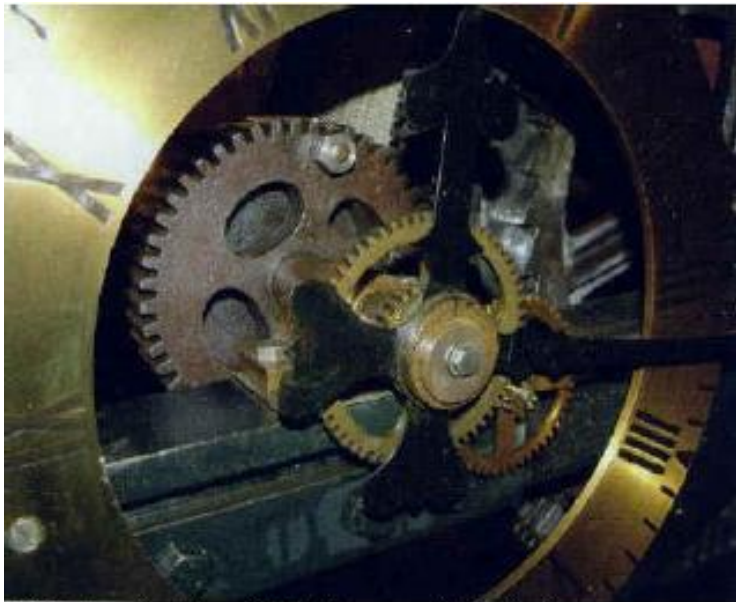
A rarely seen view; **Photo 11**, the internal pilot and setting dial at the rear of the clock. The nut on the gear wheel is one of two that clamp up the hand setting mechanism. Nothing subtle about this one, unlike many smaller tower clocks that have more user-friendly hand release clutches or knurled lockdown knobs!

11. Internal setting dial at the rear of the clock.

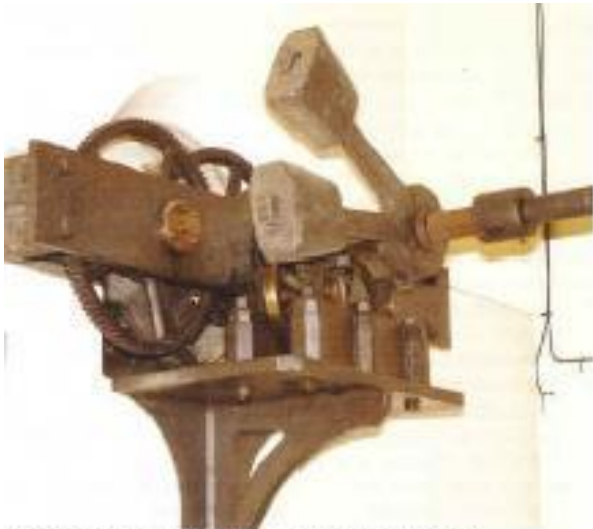
13. Internal hand counter-weights.

Since the hour tube is about 12 feet from the floor, scaffolding was installed to reach the behind-the-dial components, **Photo 12**. The tubes reaching the hands are supported by roller wheels. There are two sets of these for each dial for the hour and minute arbors. In the past some of these rollers had seized up leading to flats on the surfaces of some of these rollers. This is an indication of the sheer power that is delivered by the movement, **Photos 13 and 14**.

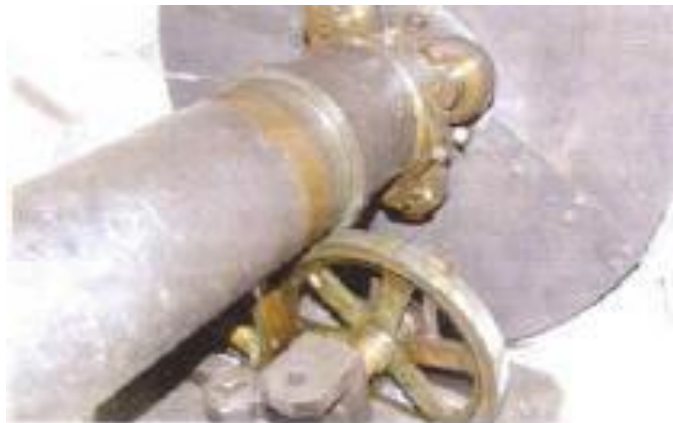
14. Friction rollers behind the dial.

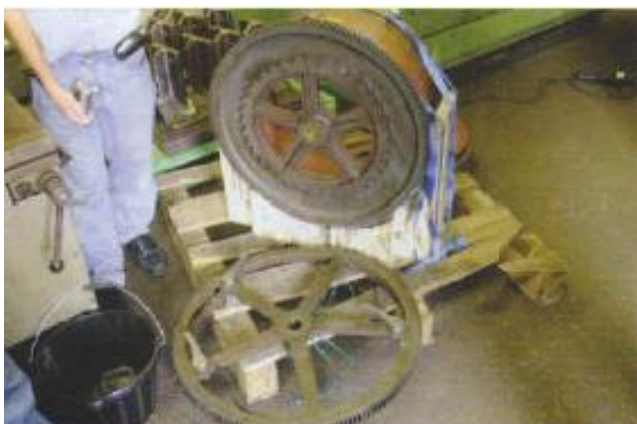
17. Going barrel before bush and washer replacement.

All bushes were replaced with new bronze, and it was decided to make a new arbor. The going barrel needed new bronze bushes, **Photo 17**. The old thrust washer had worn thin which lead to the end bolts mounted on the barrel to rub on the great wheel arms when being wound, and was replaced. With the flat bed frame stripped of most parts, **Photo 18**, the frame members were inspected and other parts were inspected and cleaned.

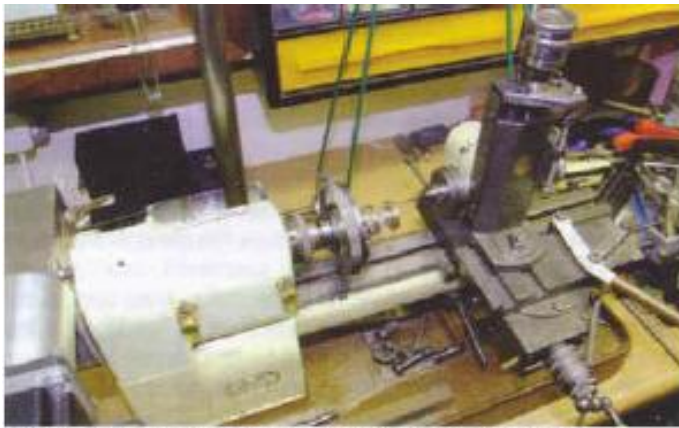
21. Drilling the lantern pinion of the escapement.

As the major components came back from the engineering works they were hoisted up the tower and installed; the going train first, then the striking **Photo 19**, next page. The strike barrel great wheel and arbor are first tested for true and smooth running. Afterward the huge barrel is installed and everything tested again, **Photo 20**, next page. Train and winding wheels were then reinstalled along with all the locking and release levers. Other work, on a smaller scale **Photos 21 and 22**, next page, was carried out on the escapement itself, replacing the worn lantern pinion rods.
